# Living Streets

## Community Street Audit Report

**Kinross**

**March 2018**

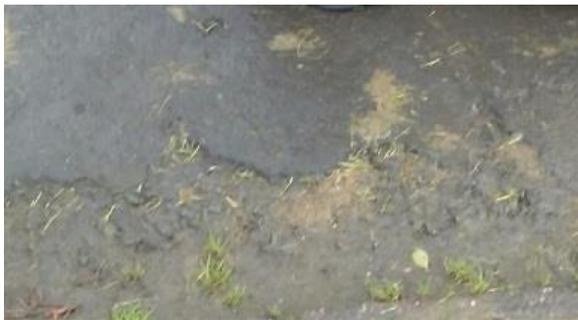
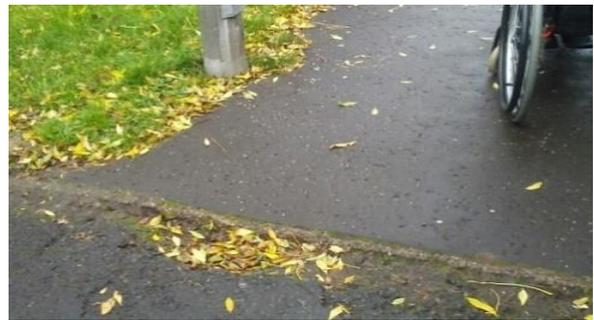
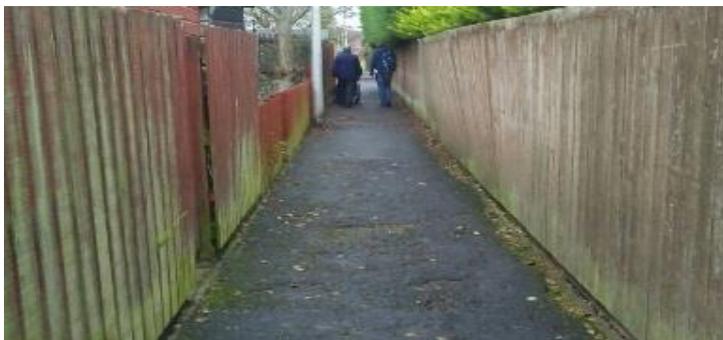
Greenpark path surface

There is an access path from Green Road, beside the Costcutter and the play park, to McBain Place, which runs parallel to Green Wood. This path was put in by the developers of the Green Park development but has been allowed to fall in to disrepair since being installed. In addition, the fencing at the boundary of Green Wood is in poor repair and is leaning over the path. Local residents that are wheelchair users find this path very uncomfortable to use due to an uneven surface and potholes, indeed on the audit one gentleman had his feet dislodged from the wheelchair footplates by the motion of moving along the path. One carer said that they would normally take a much longer route to get to the health centre or community campus to avoid having to use this path. The residents suggested that if the path was maintained it would be a good accessible short cut to the High Street and local amenities for the elderly and less mobile. There is some work to be done to check if this path has been adopted by PKC and to contact Green Wood residents to maintain the boundary fence.

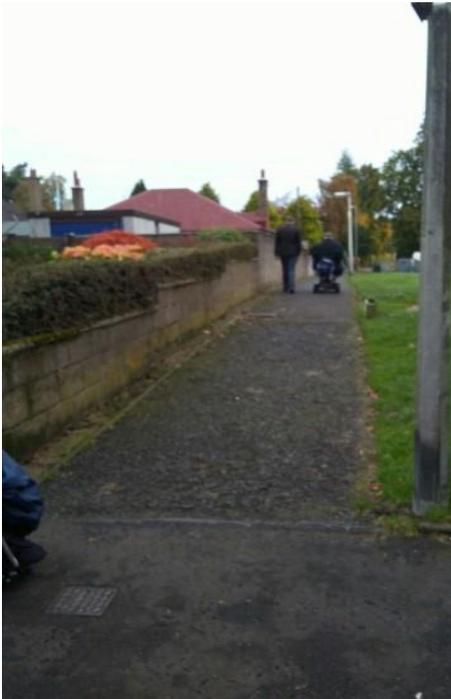
Path from Lomond Pl to Gallowhill Rd

The path from Lomond Place to Gallowhill Road is in very poor repair with a very uneven surface. As with the Greenpark path, repair and maintenance of this path would provide an accessible useful short cut for the less mobile. At the Gallowhill Road end of the path there is a metal barrier. The barrier is an obstruction to wheelchair, pushchair and mobility aid users. This barrier is due to be removed in the near future.

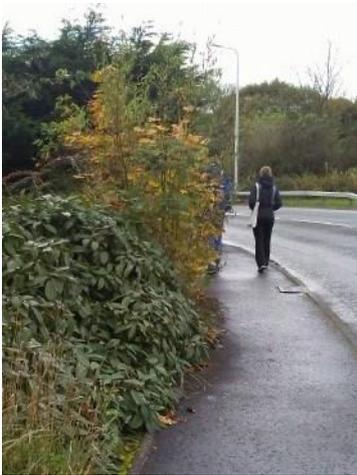
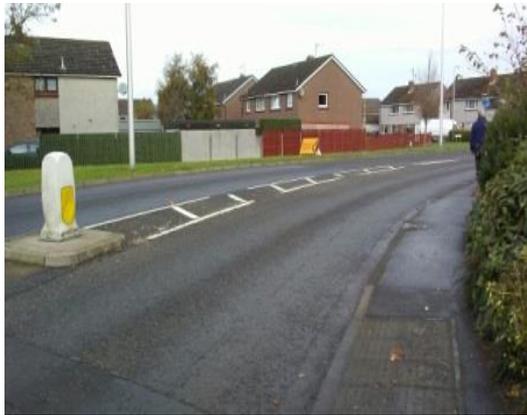
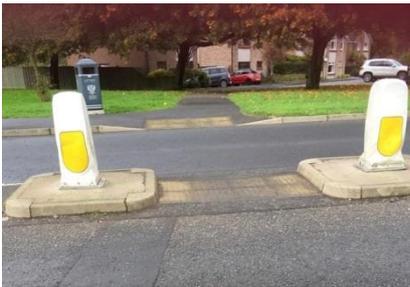
Crossing at Springfield Rd

There is a desire line crossing on the Corner of Springfield Road near Wilson Court, going to the park area, which is also used by school children going to Sainsburys at lunch time. Cars are usually travelling fast around this corner having just come from or going to the motorway. This corner is busy and with new housing being built nearby it is set to become busier. Previously an island has been installed to improve the safety of the crossing. The audit group noted that the sight lines on both approaches to the corner were poor and could be improved by cutting back the foliage near Wilson Court. The group discussed several possible solutions to make the crossing safer. The options discussed included installing a signalised crossing, reduced speed limit to 20mph, signage highlighting pedestrians crossing, and rumble paint section on the road.

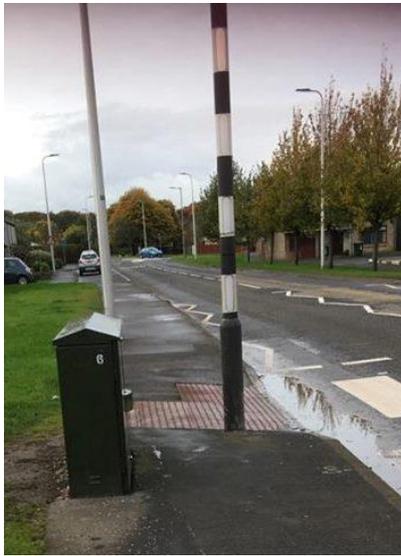
Zebra crossing on Springfield Rd

There is a zebra crossing on Springfield Road near the junction with Springfield Park. This is in fairly good condition, with tactile paving and dropped kerbs. The main issue with the crossing is the close proximity of the telecoms box to the crossing pole. This makes it difficult for people that use wheelchairs, mobility scooters, mobility aids or pushchairs to navigate past. The easiest solution would be to move either the telecoms box a few metres or to move the crossing pole and tactile paving to the crossing side furthest from the telecoms box. There is also evidence of pooling water at the kerb, indicating a drainage issue. This would be difficult for people with a visual impairment or many using mobility aids to avoid stepping in.

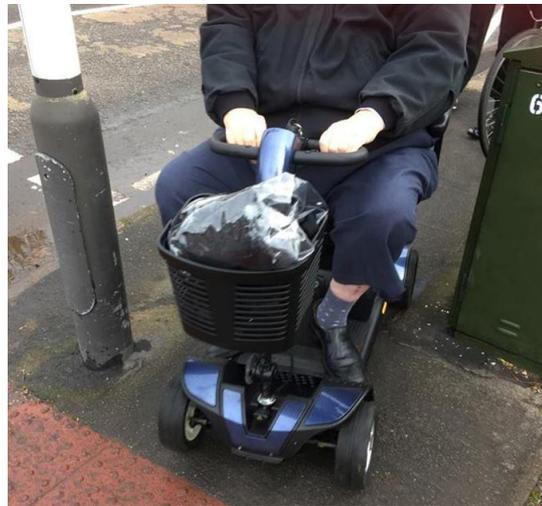
## 5 – Obstacles on Bowton Road

There are three obstacles that partially block the pavement on Bowton Road, between Whyte Court and Montgomery Road. There are two bollards and a grit box, stopping someone using a wheelchair, mobility scooter or pushchair using the pavement. As there is only a pavement on one side of the road at this point it forces these pedestrians on to the road. On speaking to the transport officer they could give no useful reason for the bollards being in place. It was suggested that these could be removed quite easily and that the grit box could be moved to a less obstructive place.

Area/Issue	Recommended Action	Level of Action Quick Win/ long Term	Responsibility/ Involvement
1 - Obstructions	1 – Remove the two bollards from Bowton Road. 2 – Move the grit box on Bowton Road. 3 – Metal railings at Gallowhill Road, at the end of the path from Lomond Place. 4 – Wheelie bins blocking footways, ensure these are left not blocking the footway.	1 – Quick win 2 – Quick win 3 – Quick win 4 – Quick win	PKC
2 – Footway Surfaces	1 - Green Park path needs resurfaced. 2 - Path between Lomond Place and Gallowhill Road needs resurfaced	1 – Long term 2 – Long term	PKC, housing developers and home owners in Green Wood.
4 – Footway Surfaces	1 – Montgomery Road, level the dropped kerb in the disabled space. 2 – Station Road, extend and repair the dropped kerb near the Primary School entrance. 3 – Green Road, install a dropped kerb at the Costcutter shop. 4 – Green Road, install a dropped kerb at the start of the Green Park path. 5 – Springfield Road, install a dropped kerb at the junction with Springfield Park. 6 – Gallowhill Road, extend and repair the dropped kerb at the end of the path from Lomond Place. 7 – Repair the dropped kerbs on the Muirs kerbs at the junction of Lathro Park. 8 – Repair the dropped kerbs on the Muirs kerbs at the junction of Gallowhill Road. 9 – Repair the dropped kerbs on the Muirs kerbs at the junction of Broom Road. 10 – Repair the dropped kerbs on the Muirs kerbs at the junction of Springfield Road. 11 – Repair the dropped kerbs on the Muirs kerbs at the junction of Muirfield Grove. 12 – Repair the dropped kerbs on the Muirs kerbs at the access to Green Hotel. 12 – Repair the dropped kerbs on the Muirs kerbs at the junction of Green Road.	1 – Quick win 2 – Quick win 3 – Quick win 4 – Quick win 5 – Quick win 6 – Quick win 7 – Quick win 8 – Quick win 9 – Quick win 10 – Quick win 11 – Quick win 12 – Quick win	PKC

Action	Responsibility
Remove the two bollards from Bowton Road.	PKC Roads team
Move the grit box on Bowton Road.	PKC Roads team
Remove the metal railings at Gallowhill Road, at the end of the path from Lomond Place. (Possibly already planned) and extend and repair the dropped kerb.	PKC Roads team
Wheelie bins blocking footways, ensure these are left not blocking the footway.	PKC Roads team and Refuse teams
Green Park path needs resurfaced. <ul style="list-style-type: none"><li>- Identify if the path is adopted by PKC</li><li>- Identify funds to resurface path, possibly Community Links Funding.</li></ul>	PKC Roads team
Path between Lomond Place and Gallowhill Road needs resurfaced. <ul style="list-style-type: none"><li>- Identify if the path is adopted by PKC</li><li>- Identify funds to resurface path, possibly Community Links Funding.</li></ul>	PKC Roads team

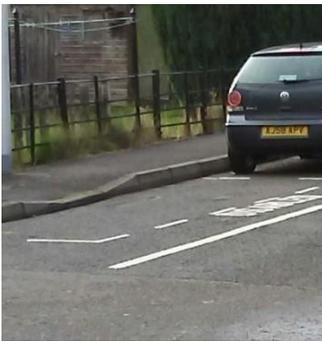
High dropped kerb on Montgomery Rd

- Montgomery Road, dropped kerb at the disabled space near the Bowton Road junction. This kerb needs to be lowered to be flush with road. In addition the width of the dropped section is also too narrow

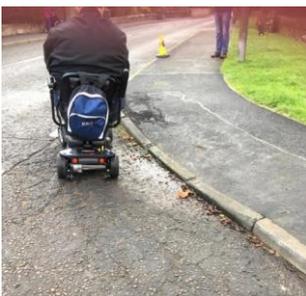
Poorly maintained dropped kerb on Station Rd

- Station Road, in front of the Primary school, kerb is poorly maintained and not dropped level to the road.

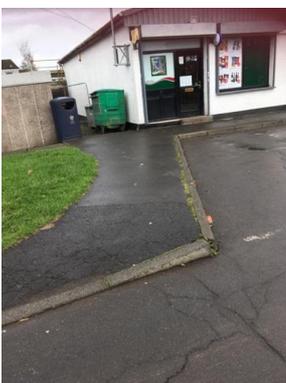
Lack of dropped kerb at Costcutter on Green Rd

- Green Road, pavement at Costcutter. This is lacking a dropped kerb.

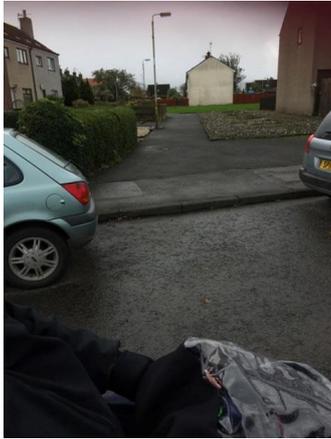
- Green Road, pavement at start of Green Park path. This is lacking a dropped kerb.

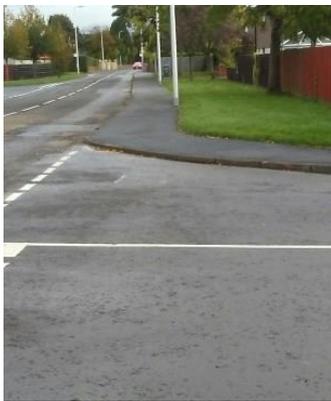
- Junction of Springfield Road and Springfield Park. This is lacking a dropped kerb.

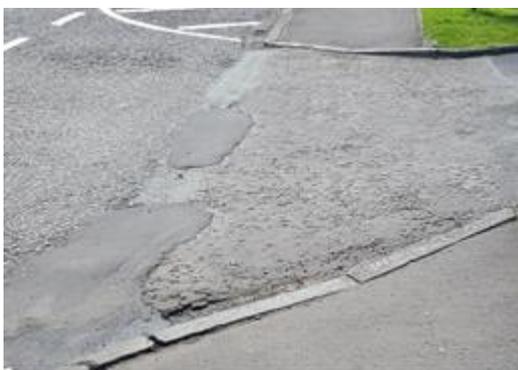
- The Gallowhill Road end of the path connecting Lomond Place to Gallowhill Road has a very small dropped kerb. The kerb needs to be extended.
- The Muirs at the entrance of Lathro Park. The footway is very steep and wheelchairs and scooters often bottom out at the dropped kerb.
- The Muirs at the junction of Gallowhill Road.
- The Muirs at the junction of Broom Road.
- The Muirs at the junction of Springfield Road.
- The Muirs at the junction of Muirfield Grove.
- The Muirs at the access to the Green Hotel.

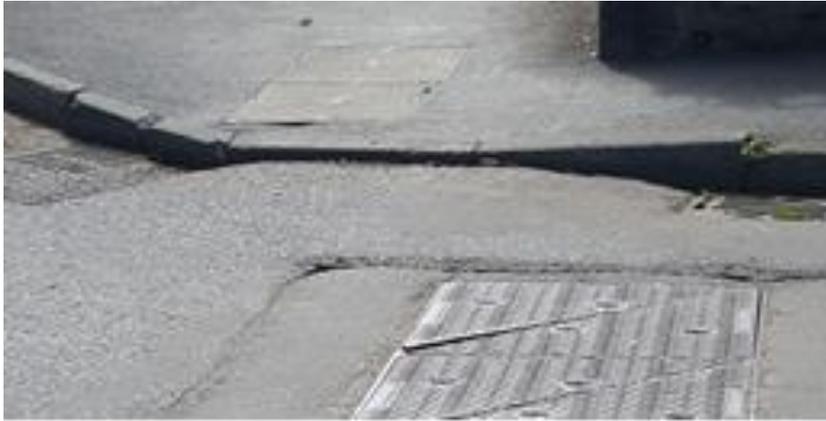
- The Muirs at the junction of Green Road

Repair/extend the dropped kerbs on the Muirs kerbs at the junction of Green Road.	PKC Roads team

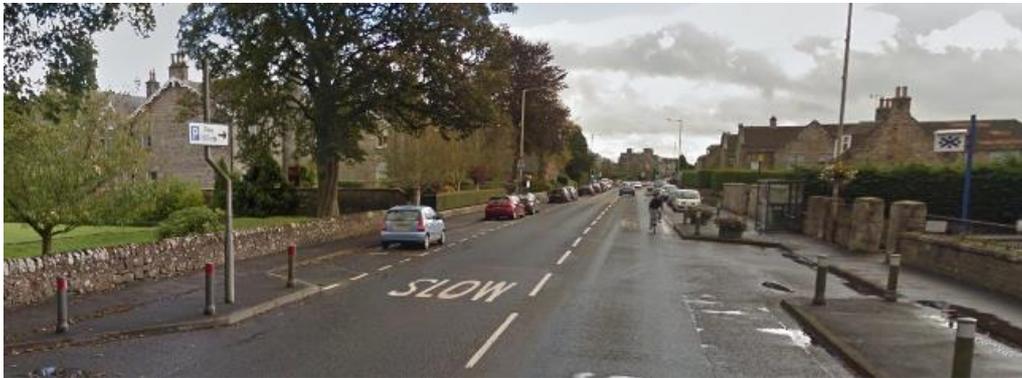
- There is a build out on the Muirs just South of Green Road, in between bus stops, it would benefit from dropped kerbs to allow pedestrians to cross with ease between the bus stops. This would also involve moving a parking sign.

<b>Action</b>	<b>Responsibility</b>
On the south side of Green Road, near the RBS, move parking sign on the East side build out to allow for installation of dropped kerb. Install dropped kerbs on both sides of the road at the build outs.	PKC Roads team

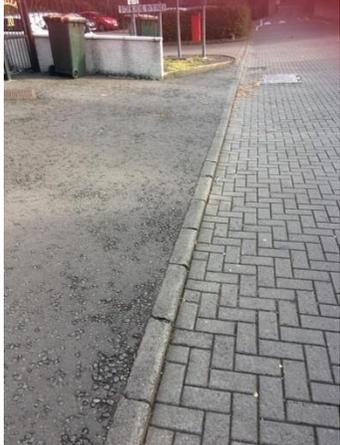
School Wynd	Lack of footpath	Have to walk on road	Road layout and space allocation	Low- no room to add footpath

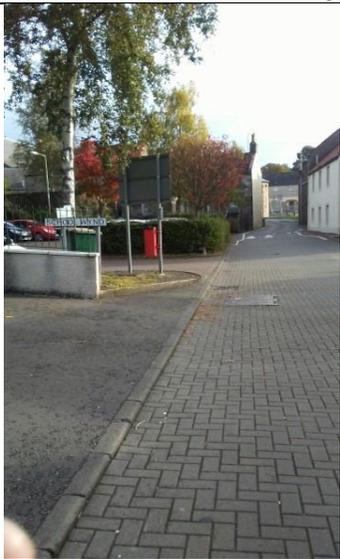
School Wynd	Lack of drop kerb after car park	Have to walk on road	Footway surfaces and obstructions	Medium – route to sheltered housing complex, add dropped kerb.

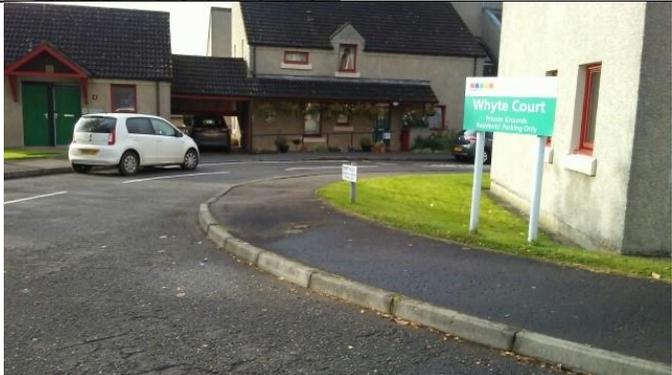
Junction of Bowton Road and Whyte Court	Degraded pavement (complaint made to Council – auditors did not view surface as too bad)	Possible trip hazard	Footway surfaces and obstructions	Low – auditors felt there were more pressing needs.

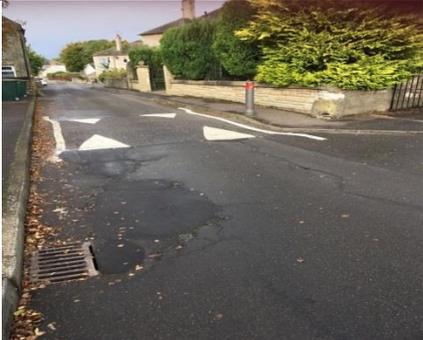
Bowton Road	Bollard on pavement narrowing width of pavement	Stops wheelchairs, mobility scooters and buggies walking along pathway	Footway surfaces and obstructions	High – no obvious need for the bollard. Remove bollard.

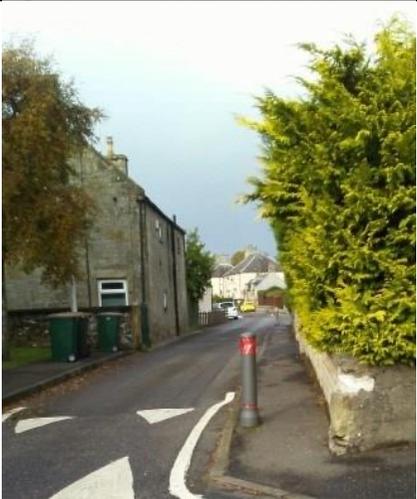
Bowton Road	Very small drop kerb next to wall. Bins in pavement	Too small and narrow for wheelchair users to turn to go down	Footway surfaces and obstructions	Low – if bollard removed from opposite pavement (see above)

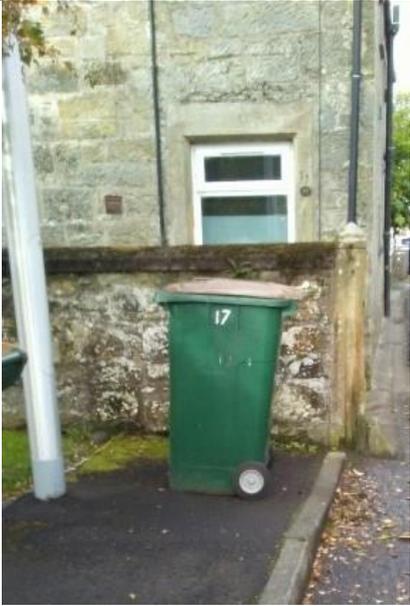
Bowton Road	Very small drop kerb next to wall. Bins in pavement	Too small and narrow for wheelchair users to turn to go down	Footway surfaces and obstructions	Low – if bollard removed from opposite pavement (see above)

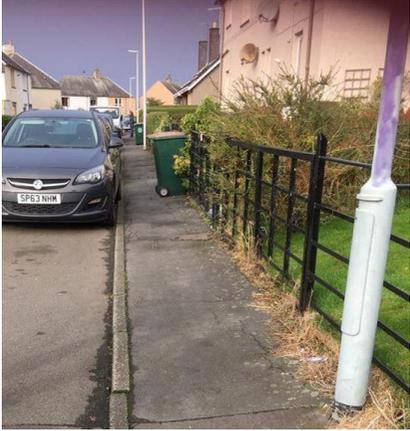
Bowton Road	Bins on pavement and sandbox blocking pavement	Blocking path for wheelchair/pushchair users	Footway surfaces and obstructions	High – ensure bin men leave path free

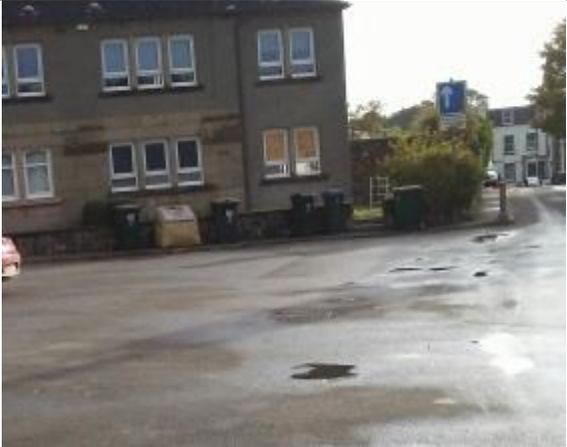
Bowton Road	Bins on pavement and sandbox blocking pavement	Blocking path for wheelchair/pushchair users	Footway surfaces and obstructions	High – ensure bin men leave path free and sandbox moved

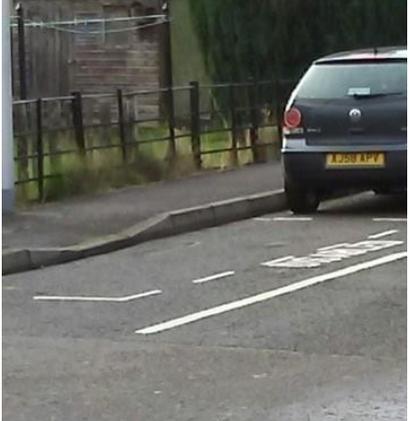
Junction with Bowton Rd and Montgomery Rd	Disabled parking bay with a dropped kerb in the middle. Dropped kerb is not flush.	Difficult for wheelchair users to use dropped kerb	Footway surfaces and obstructions	Low – reset dropped kerb

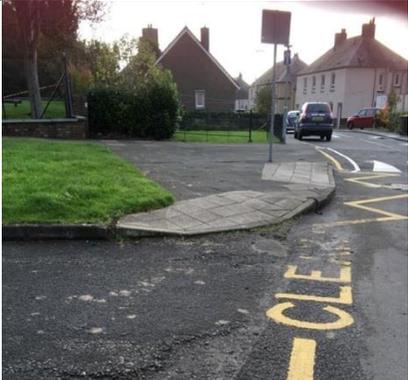
<p>Crossing opposite primary school on Bowton Rd</p>	<p>Good crossing</p>	<p>Enables easy movement at crossing</p>	<p>Footway surfaces and obstructions</p>	<p>Low – no change needed</p>

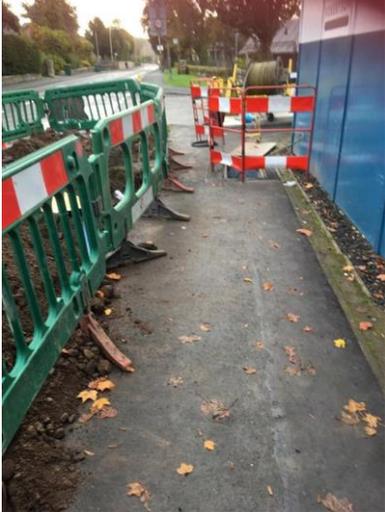
<p>Station Road, entrance to new primary school building works</p>	<p>Road works barriers blocking path</p>	<p>Wheelchair and pushchair users unable to pass.</p>	<p>Footway surfaces and obstructions</p>	<p>Low – temporary road works and BT works</p>

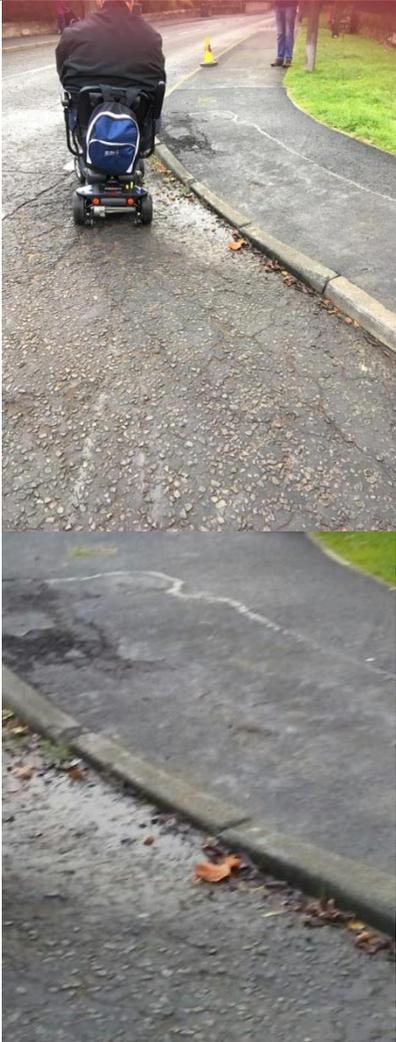
Station Road, entrance to new primary school building works	Drop Kerb too high for wheelchair and mobility scooters to access	Forces wheelchair and mobility scooters to travel on the road as they can't access the pavement	Footway surfaces and obstructions	High – main route to High St and access to primary school

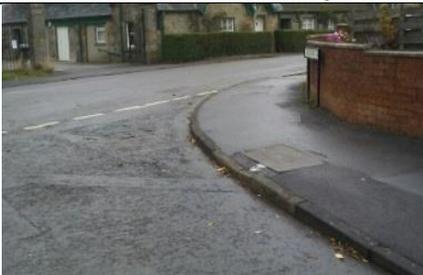
Alexander Drive	Lack of dropped kerbs	Forces wheelchair and mobility scooter users to go on the road rather than pavement	Footway surfaces and obstructions	Low – quiet streets, insert dropped kerbs
No pic yet	Alexander Drive	Cars parked on pavement	Blocks pavement forcing wheelchair/buggy users to go on the road	Footway surfaces and obstructions	Low – quiet streets, enforce pavement parking

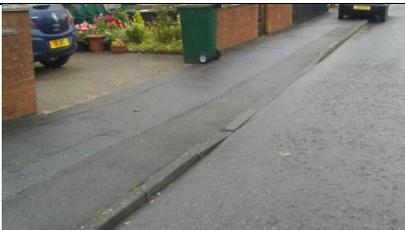
Green Road	Cars parked on pavement	Blocks pavement forcing wheelchair/buggy users to go on the road	Footway surfaces and obstructions	Low – quiet streets, enforce pavement parking

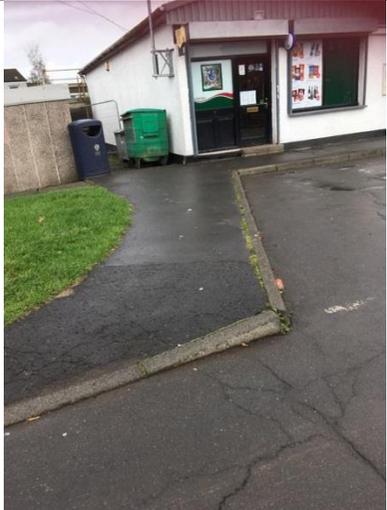
Green Road, Costcutter shop	Lack of dropped kerb	Blocks pavement forcing wheelchair/buggy users to go on the road or take long detour	Footway surfaces and obstructions	Low – Insert dropped kerb

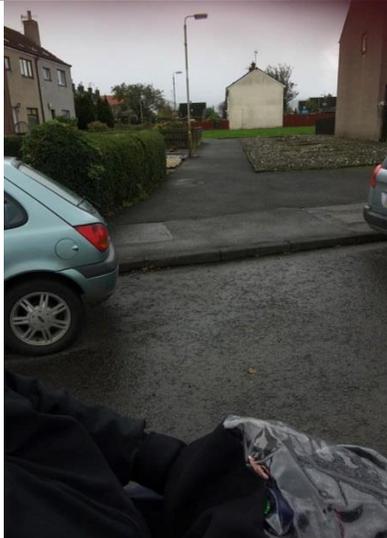
Green Road	Lack of dropped kerb at start of path	Blocks pavement forcing wheelchair/buggy users to go on the road or take long detour	Footway surfaces and obstructions	Medium – Insert dropped kerb, route to Health centre and Curling Centre

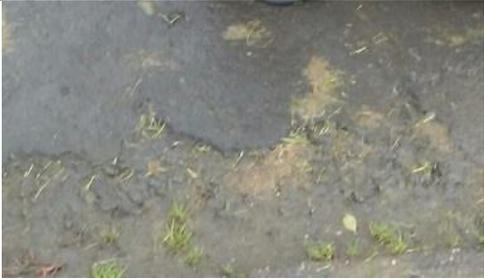
Greenpark Paths	Badly maintained path surface, muddy and rutted	Difficult to traverse with wheelchair, can cause pain to frailer wheelchair users Auditor reported legs being shaken off the footrests of wheelchair	Footway surfaces and obstructions	High – surface degrading, Path needs resurfaced

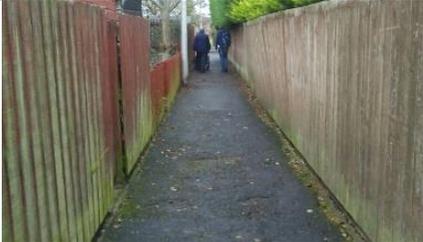
Greenpark Paths	Fence bowing into pathway	Narrowing usable path, danger of fence falling on to path and pedestrians	Footway surfaces and obstructions	Medium – trees need cutting back. And fences fixed. These belong to private houses, will need enforcing

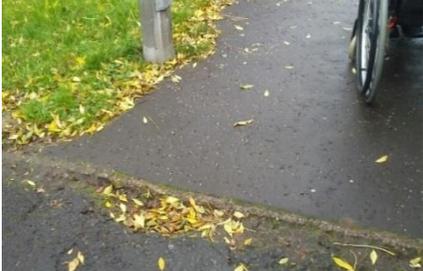
Greenpark Paths	End of path has pothole	Difficult for wheelchair, buggy users, some difficulty with wheels getting stuck. Trip hazard	Footway surfaces and obstructions	High – surface degrading, Path needs resurfaced

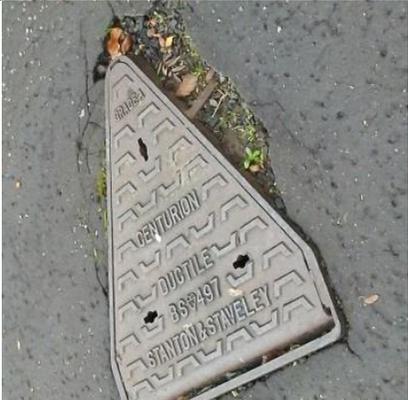
McBain Place	Badly maintained manhole cover	Trip hazard, damage to vehicles using road	Footway surfaces and obstructions	Low – road surface needs patched around cover
No pic yet	McBain Place	Steep inclines on pavements, especially to driveway dropped kerbs	Difficult for wheelchair, buggy and walking aid users. Could be dangerous in winter if icy.	Footway surfaces and obstructions	Low – flatten out the inclines.

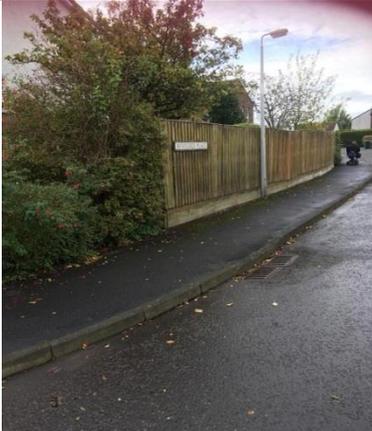
Beveridge Place	No dropped kerbs	Wheelchair and mobility scooter users are using driveways to mount/dismount pavement to cross, leads to long detours	Footway surfaces and obstructions	Low – quiet residential area.

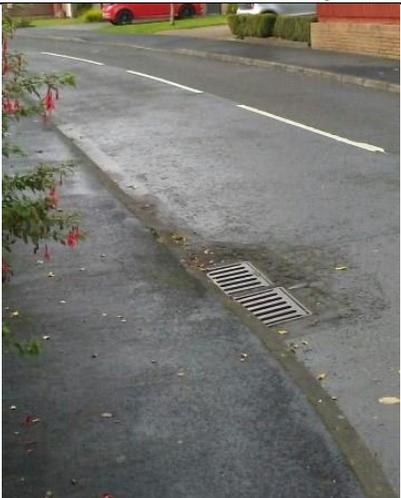
Beveridge Place	Low drains in the road where dropped kerbs would go.	Trip hazard where pedestrians would naturally cross.	Footway surfaces and obstructions	Low – quiet residential area.

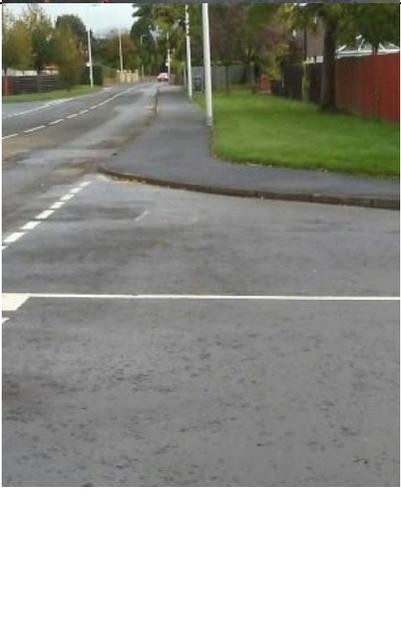
Junction of Springfield Road and Springfield Park	No dropped kerbs at junction.	Wheelchair users forced on to busy road, using driveways – causing long detours	Footway surfaces and obstructions	Medium – busy road junction.

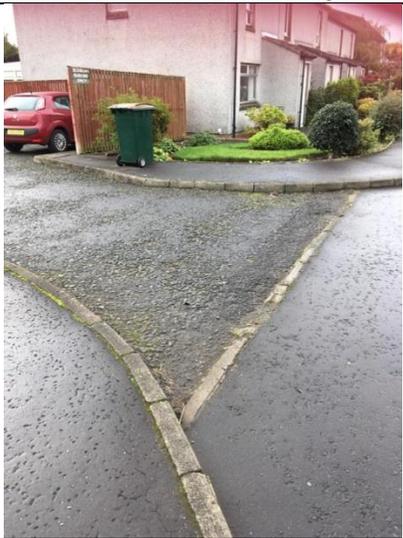
<p>Junction of Springfield Road and Springfield Park</p>	<p>No dropped kerbs at junction.</p>	<p>Wheelchair users forced on to busy road, using driveways – causing long detours</p>	<p>Footway surfaces and obstructions</p>	<p>Medium – busy road junction.</p>

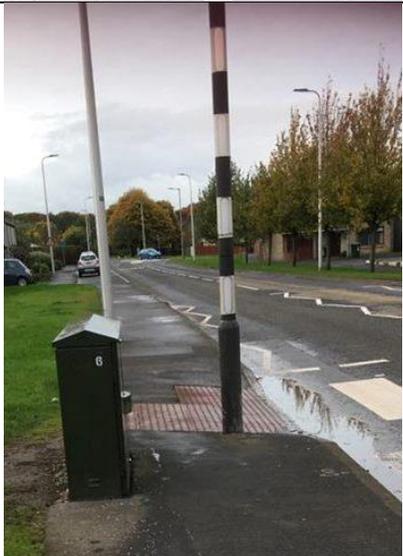
<p>Zebra Crossing on Springfield Road</p>	<p>Telephone box placed too close to Zebra crossing pole</p>	<p>Causes difficulty for mobility scooter and wheelchair/pushchair users, as turning space is very tight.</p>	<p>Footway surfaces and obstructions</p>	<p>High – move pole to other side of the tactile paving on the BT box side.</p>

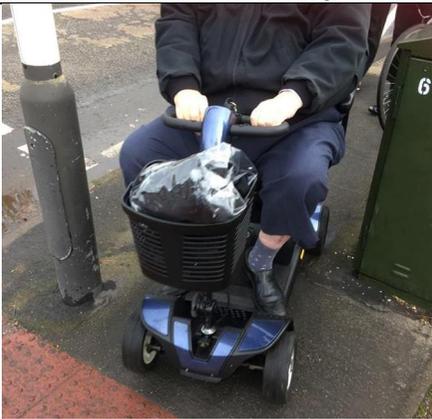
Zebra Crossing on Springfield Road	Telephone box placed too close to Zebra crossing pole	Causes difficulty for mobility scooter and wheelchair/pushchair users, as turning space is very tight.	Footway surfaces and obstructions	High – move pole to other side of the tactile paving on the BT box side.
No pic yet	Springfield Road	No dropped kerbs on one side of the road.	Wheelchair and mobility scooter users will need to go on one side of the road for ease of access. May lead to crossing at blind corner further up the road on the route to Sainsbury's.	Footway surfaces and obstructions

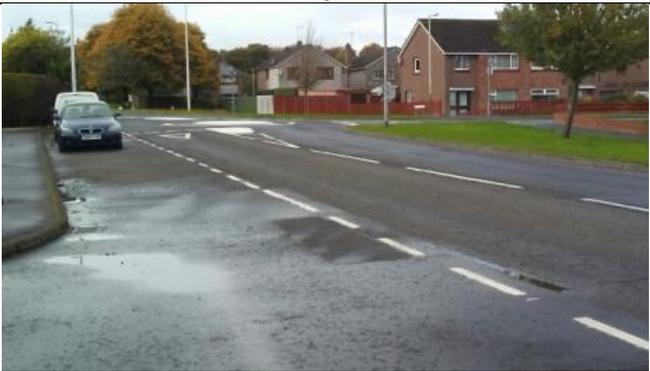
Springfield Road roundabout.	Cars speed at this junction, especially when coming from the motorway side, round a blind corner. Worry that this will get even busier as 300-400 new houses are being built and this is main route to motorway	Difficult for frailer /slower pedestrians and wheelchair/pushchair users to cross due to volume and speed of traffic.	Traffic	High – traffic calming measures on both approaches on Springfield Road, textured red road surface, 20mph limit

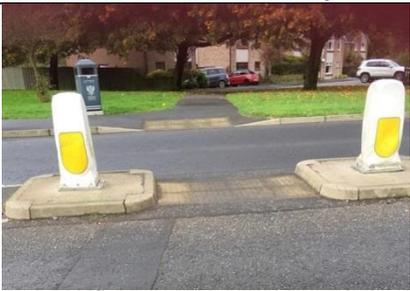
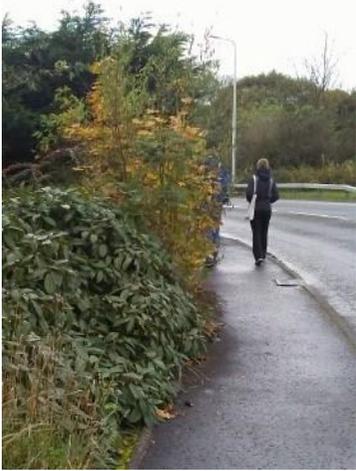
Corner on Springfield road just past the mini roundabout.	Crossing Island on busy corner with limited sight lines.	Busy corner, route to Sainsbury's (used by school pupils at lunch time) and Park space. Was being used as a crossing, an island was put in as a refuge for pedestrians. This is a fast road as cars have just come from the motorway. There are	Traffic	High – Cutting back bushes and plants. Possible 'slow down pedestrians crossing' signs on approach to corner or speed bumps/rumble strips on approach.

bushes/plants that obscure the view of the road. 300-400 new houses being built so traffic set to increase in the next year or so.

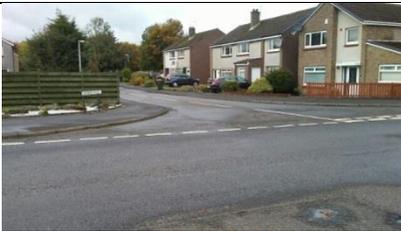
Katrine Place	No drop kerbs in new estates	Causes long detours for wheelchair and Mobility scooter users	Footway surfaces and obstructions	Low – quiet residential area.

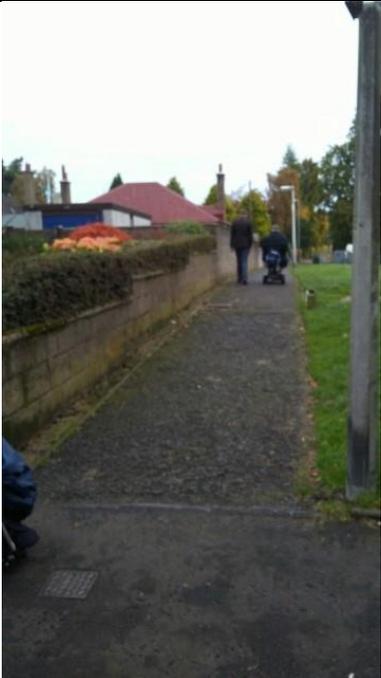
Path between Lomond Place and Gallowhill Road	Path surface is badly maintained	Causes discomfort for wheelchair, mobility scooter users. Trip hazard for walkers.	Footway surfaces and obstructions	High – Resurface path, fairly short length and on main route to Health Centre and Community Campus

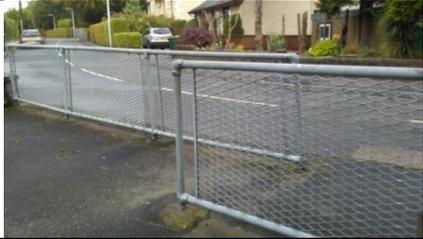
End of path at junction with Gallowhill Road	Metal barriers at end of the path	Difficulty for pushchair, wheelchair and mobility scooter users.	Footway surfaces and obstructions	High – Barriers are due to be removed
No pic yet	End of path at junction with Gallowhill Road	Very small dropped kerb near wall, next to metal barriers.	Difficulty for pushchair, wheelchair and mobility scooter users.	Footway surfaces and obstructions	High – when barrier is removed dropped kerb should be extended.

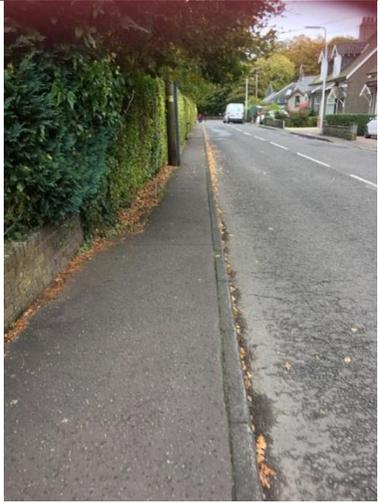
Gallowhill Road	Pavement narrowed due to overgrown hedge.	Difficulty for pushchair, wheelchair and mobility scooter users.	Footway surfaces and obstructions	Low – Although bushes have grown over the pavement, Councillor has looked into enforcement of cutting them back. This would be complicated and expensive to do.

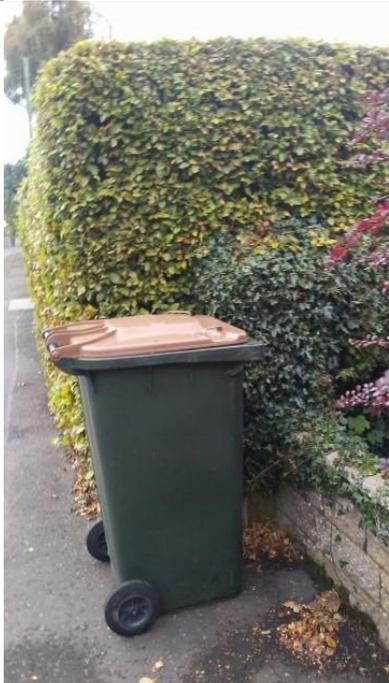
Gallowhill Road	Pavement narrowed due to overgrown hedge.	Difficulty for pushchair, wheelchair and mobility scooter users.	Footway surfaces and obstructions	Low – Although bushes have grown over the pavement, Councillor has looked into enforcement of cutting them back. This would be complicated and expensive to do.

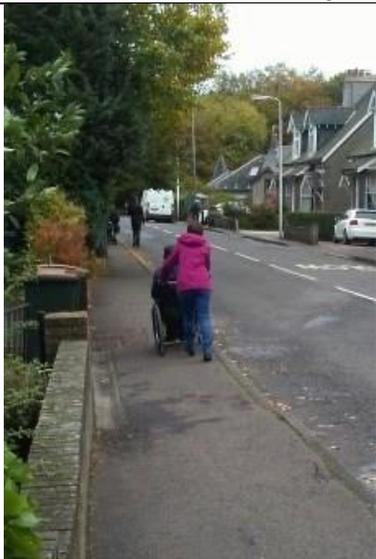
Gallowhill Road	Driveway entrances have steep pitches	Difficult for wheelchair, pushchair and mobility scooters to use. Especially in icy conditions.	Footway surfaces and obstructions	Low – level out pitch
No pic yet	Entrance to Lathro Park	Steep pavement	Wheelchair and mobility scooters bottom out on pavement.	Footway surfaces and obstructions	Medium – Level out the slope
No pic yet	Broom Road	Steep pavement	Wheelchair and mobility scooters bottom out on pavement.	Footway surfaces and obstructions	Medium – Level out the slope

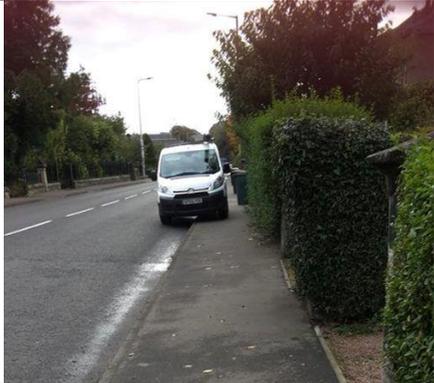
Muir	Pavement parking	Blocks pavement forcing wheelchair/buggy users to go on the road	Footway surfaces and obstructions	Low – quiet streets, enforce pavement parking

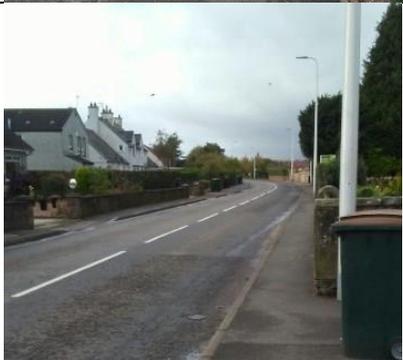
Junction of Station Road and Muir	Narrow pavement on both sides of the road, exacerbated by HGV using road as diversion to St Andrews.	Intimidating to walk along the road towards junction. Especially if meeting other pedestrians, with children or using wheelchair/mobility scooter. Difficult road to cross if visually impaired or slow walker.	Footway surfaces and obstructions/Traffic	Low/Medium – HGV and increased traffic temporary due to detour. Narrow road so no space to increase pavement size. Add crossing?
