Living Streets

Community Street Audit Report

Pitlochry
March 2018

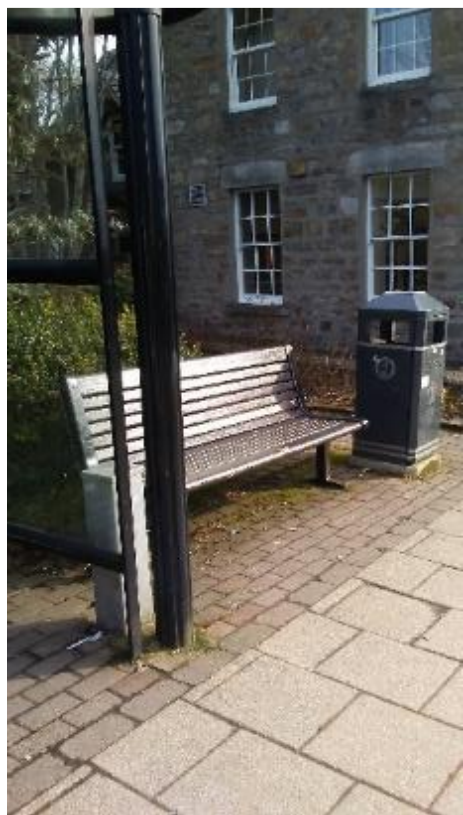
Seating at bus stop

The provision of seating along the high street, some of which has cover. There is usually a litterbin nearby and near the bus stance there are public information signs as well as bus information.

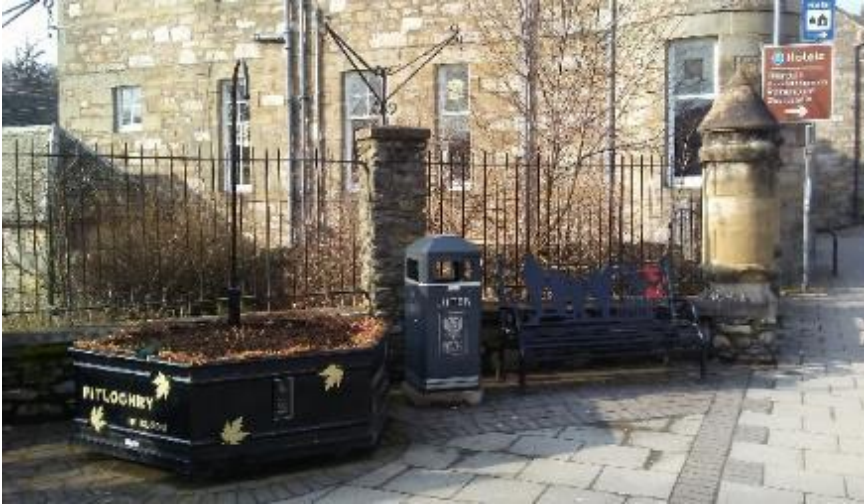
Entrance to War Memorial and Garden

The War Memorial and memorial gardens are well kept and looked after. There is seating and this is a lovely space to spend some time.

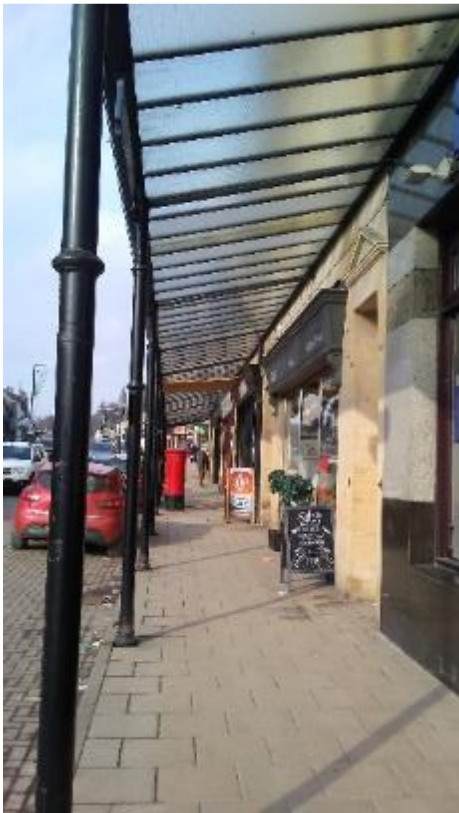
Covered arcade

The covered arcade is an unusual town feature and can make shopping a bit more inviting in wet weather.

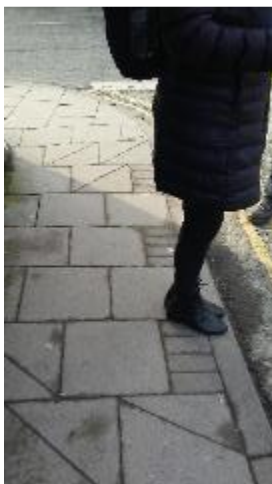
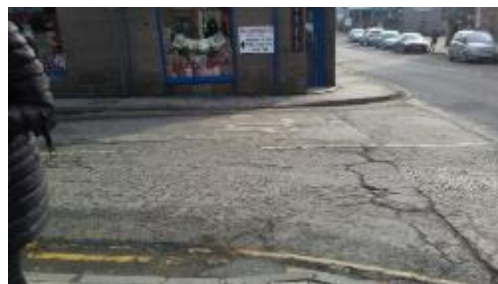
Bonnethill Road crossing

- Crossing Bonnethill Road is difficult for wheelchair and pushchair users due to the narrow footway outside Cards and Co making it difficult for them to manoeuvre. There are also dropped kerbs on each side of the road but these are misaligned, this is confusing for visually impaired and means that wheelchair users have to cross at an angle rather than going straight across the road.

3 – Footway Surfaces (dropped kerbs)	1 – Bonnethill Road, align and reset the dropped kerbs flush to the carriageway, widen the footway beside Cards & Co 2 – West Moulin Road, align the dropped kerbs so they don't lead to an arcade pole. Reset the dropped kerbs flush to the carriageway. 3 – Ferry Road, upgrade the surface of the footway and carriageway, align and reset the dropped kerbs flush to the carriageway. Widen the footway on the Victoria's side of the road. 4 – Birnam Place, widen the footway on the Mckays Hotel side of the road. 5 – Burnside Road, align and reset the dropped kerbs flush to the carriageway. Upgrade the footway and carriageway surfaces.	1 – Medium term 2 – Quick win 3 – Medium term 4 – Medium term 5 – Medium term	PKC

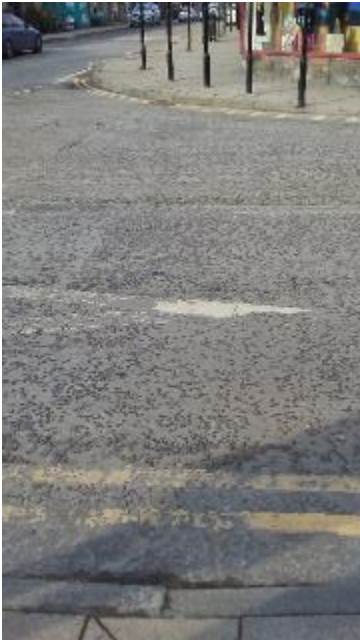
West Moulin Road crossing

- Crossing West Moulin Road is difficult for both the visually impaired and wheelchair users due to poorly maintained and misaligned dropped kerbs and also the poles for the arcade block the footpath if crossing in a straight line from the Chemist side of the road. As this is an awkward section to cross, pedestrians often cross Atholl Road at the Chemist from Keepsakes rather than using the pedestrian crossing to the north at Pitlochry Knitwear.

Action	Responsibility
West Moulin Road, align the dropped kerbs so they don't lead to an arcade pole. Reset the dropped kerbs flush to the carriageway.	PKC Roads team
Ferry Road junction with Atholl Road <ul style="list-style-type: none"> - Repair the surface of the footway and carriageway - Align and reset the dropped kerbs flush to the carriageway - Widen the footway on the Victoria's side of the road 	PKC Roads team
Birnam Place junction with Atholl Road, widen the footway on the Mckays Hotel side of the road.	PKC Roads team
Burnside Road beside the Cancer research shop <ul style="list-style-type: none"> - Repair and reset the dropped kerbs flush to the carriageway - Upgrade the footway and carriageway surfaces 	PKC Roads team
Pedestrian crossing at Pitlochry Knitwear <ul style="list-style-type: none"> - Replace the missing tactile paving outside the shop - Move the litterbin out of tactile paving crossing line - Repair the dropped kerbs. 	PKC Roads team

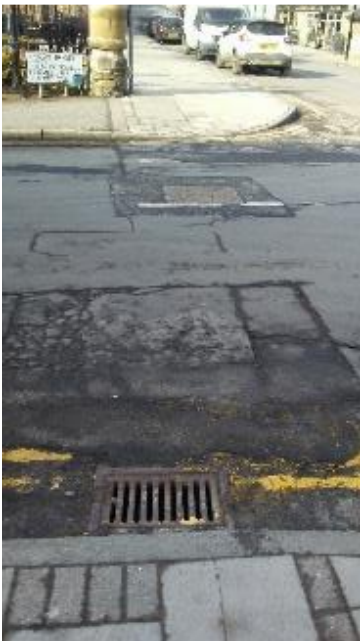
Ferry Road crossing

- Crossing Ferry Road is difficult for less mobile pedestrians and wheelchair and pushchair users. The footway on the Victoria's side of the road is narrow, steep and on a camber. The dropped kerbs are misaligned and poorly maintained as is the footway and carriageway. This is a main route to the Community Hospital, Care Home, GP surgery and car park so is potentially busy with less able pedestrians.

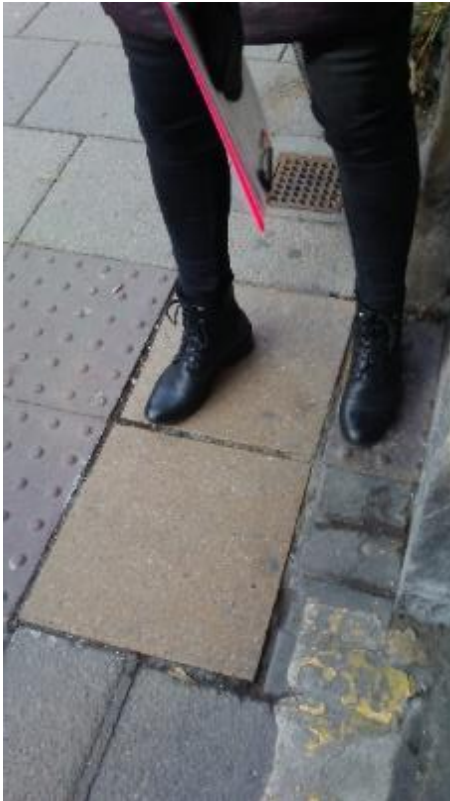
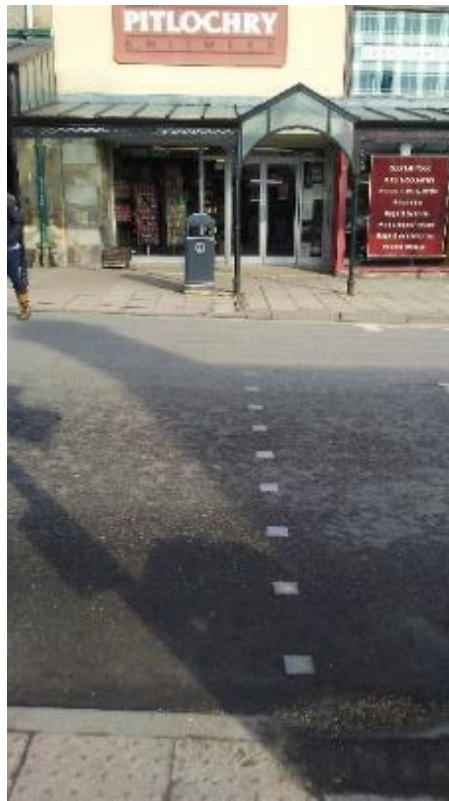
Missing tactile paving and pedestrian crossing

- Pedestrian Crossing at Pitlochry Knitwear has missing tactile paving on the Pitlochry Knitwear side of the road at the wall and the dropped kerb is badly maintained. If visually impaired pedestrians use the tactile paving to cross Atholl Road from Just the Ticket, they would walk into a litterbin which has been placed at the crossing in front of Pitlochry Knitwear.

Area/Issue	Recommended Action	Level of Action Quick Win/ long Term	Responsibility/ Involvement
4 – Crossing Points	1 – Pedestrian crossing at Pitlochry Knitwear, replace the missing tactile paving outside the shop. Move the litterbin out of tactile paving crossing line. Repair the dropped kerbs. 2 – Pedestrian Crossing near Elm Court, repair the carriageway at the crossing.	1 – Quick win 2 – Medium term	PKC

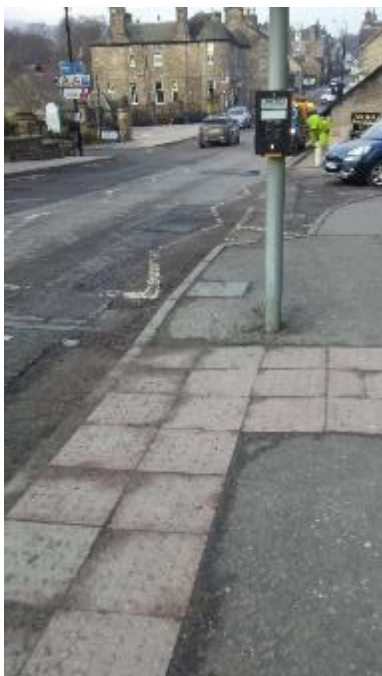
- Pedestrian crossing near Elm Court has good tactile paving but is made difficult to cross due to the poor surface on the carriageway.

Pedestrian Crossing near Elm Court, repair the carriageway at the crossing.	PKC Roads team

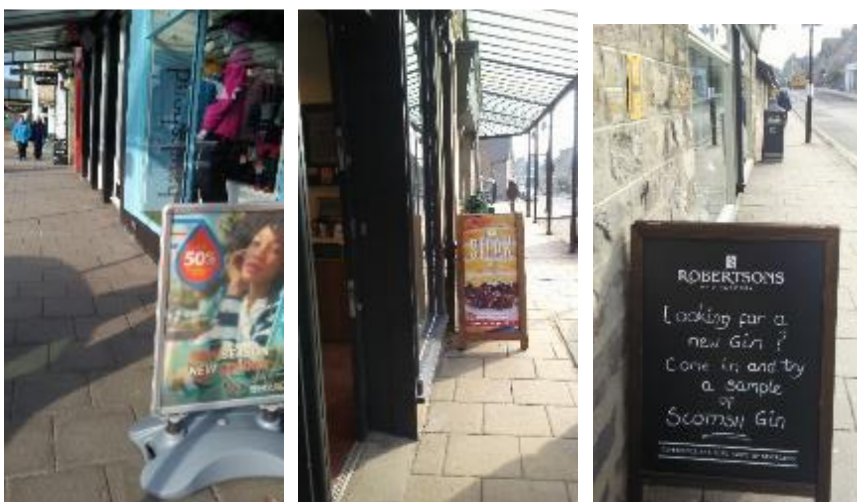
Advertising boards along Atholl Road

These are to be found along the length of Atholl Road. PKC has spoken to local business owners, re-iterating the guidelines for best placement of boards. One business was seen to chain their advertising board to an arcade post.

Area/Issue	Recommended Action	Level of Action Quick Win/ long Term	Responsibility/ Involvement
1 - Obstructions	1 – Advertising Boards in the town centre, also cones and bread pallets, ensure that business owners are aware of regulations and these are enforced. 2 – Raised section of footway outside Edinburgh Woollen Mill, repaint the edges to highlight the height difference. 3 – Lamp post and sign near Keepsakes, move the sign, one side to the side of the building (heading North) and the other side nearer to Mountain Warehouse (heading South) 4 – Hardware store, improve the footway at the corner, remove the bollard and highlight the low roofline.	1 – Quick win 2 – Quick win 3 – Medium term 4 – Medium term	PKC and business owners
2 – Footway Surfaces (maintenance)	1 – Atholl Centre to Elm Court, footway resurfaced focussing on kerbs at Tourist Information, Car Park, Police Station and Elm Court 2 – Keepsakes, upgrading the footway outside the shop 3 – Fishers Car Park entrance, level off the join between footway and car park. Reset utility covers and maintain the surface near the kerb.	1 – Quick win 2 – Quick win 3 – Medium term	PKC and business owners

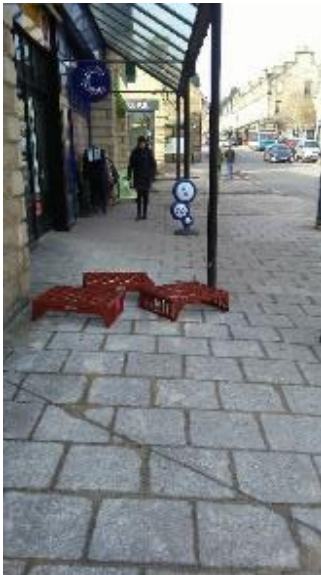
Bread pallets obstructing the footway

These were scattered on the footway outside the Premier Shop in addition to an advertising board. These pose a trip hazard for the visually impaired as they are unexpected, low and near the shop entrance. As the Post Office is housed inside the Shop this can be a busy entrance.

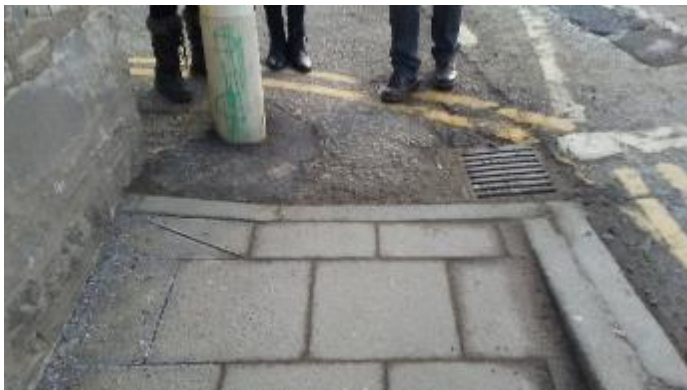
Bollard and low roofline at the Hardware store

The hardware store is situated on the corner to the entrance to the Atholl Business Centre. This is a poorly maintained road and a narrow start to the footway. This start to the footway is partially blocked by a bollard, poorly maintained drain and raised kerb. The building has a very low roofline and this is a hazard for pedestrians.

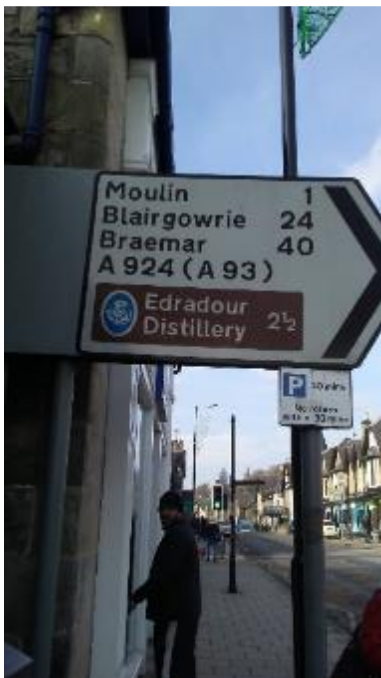
Signs and lamp posts blocking the footway

There is a traffic sign held by two posts which is situated very close to a lamp post. Together these posts partially block the footway at the point where it narrows due to the start of the parking spaces.

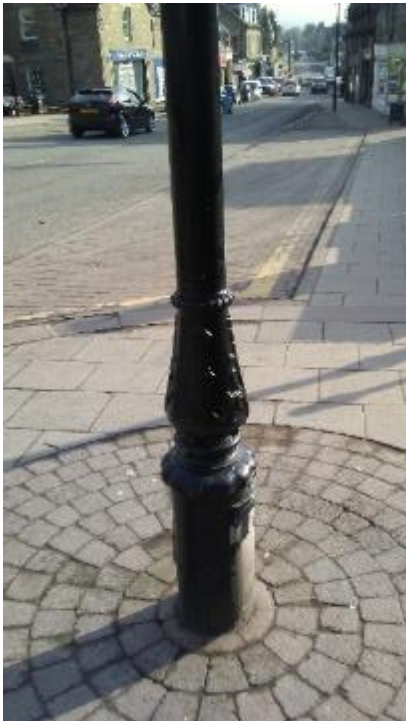
Post holding clock outside Fisher's Hotel

Outside Fishers Hotel, opposite the Royal Bank of Scotland there is a covered seating area and a post with a clock. Due to this being situated just before a bus stop on a built out section of footway, as pedestrians walk South along Atholl Road the clock post is in the middle of the footway. This can be hazardous for the visually impaired.

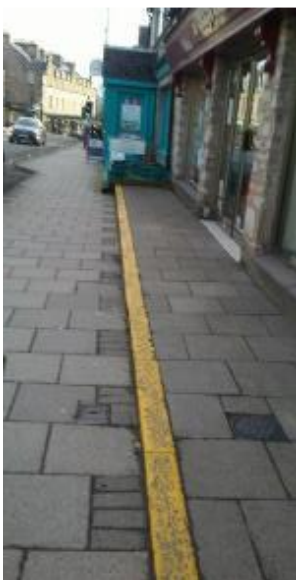
Raised pavement at Edinburgh Woollen Mill

There is a raised section of the pavement in front of the shop. This is a long ramp to allow access to the entrance. This could be a trip hazard for visually impaired. The edge of the raised section is painted yellow, but this could be repainted to make it more obvious.

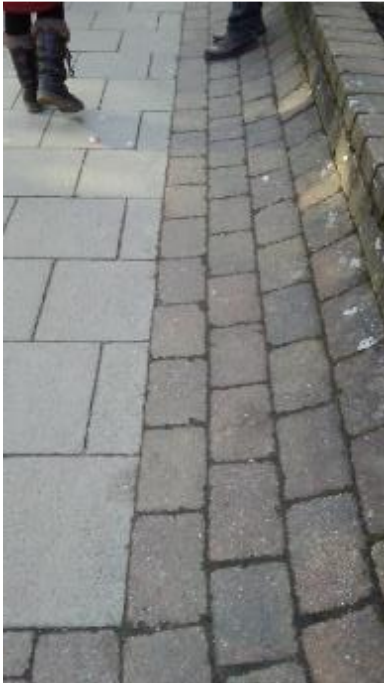
Low wall at Fisher's Hotel

There is a low wall in front of Fishers Hotel, this does not form a right angle with the pavement but a gentle curve. This could be a trip hazard for the less mobile or visually impaired.

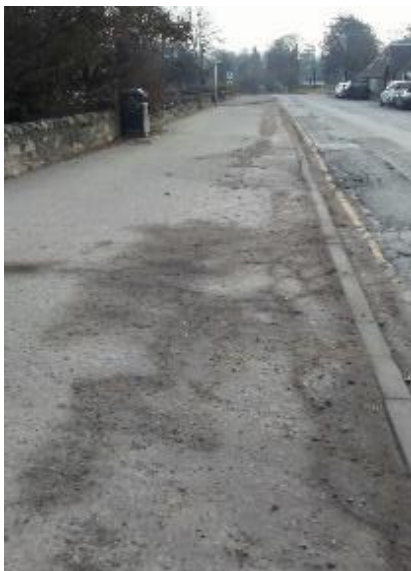
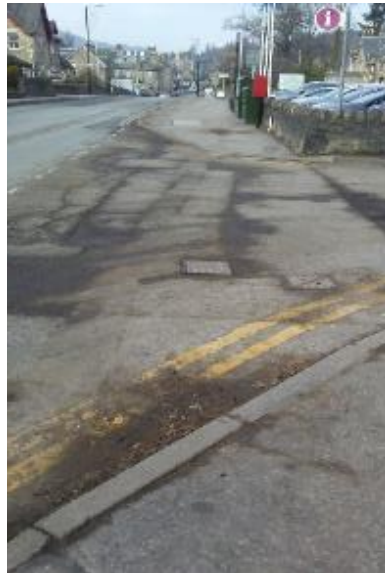
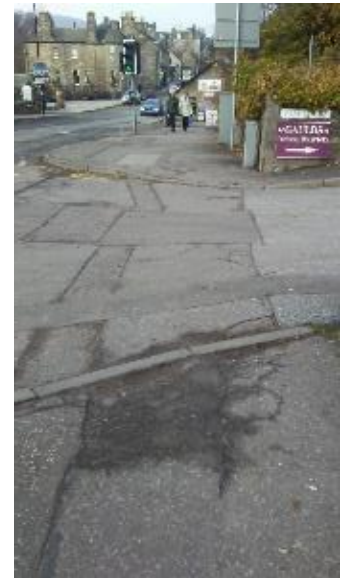
Poor footway surface between Atholl Centre and Elm Court

When walking along Atholl Road there are some areas that are poorly maintained, some also have loose chippings. The entrances to the Tourist Information centre, Car Park, Police Station and Elm Court are also poorly maintained, especially at the kerbs.

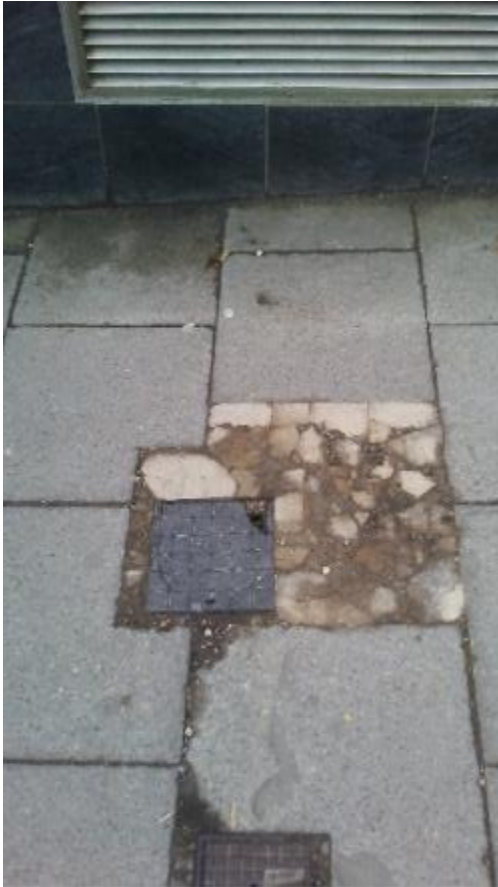
Poor footway outside Keepsakes

The footway outside the shop has a poorly maintained section that could be a trip hazard for pedestrians.

Keepsakes, upgrade the footway outside the shop	PKC Roads team
Fishers Hotel Car Park entrance <ul style="list-style-type: none"> - Level off the join between footway and car park - Reset utility covers - Repair the surface near the kerb. 	PKC Roads team and business owner
Bonnethill Road junction with Atholl Road <ul style="list-style-type: none"> - Realign and reset the dropped kerbs flush to the carriageway - Widen the footway beside Cards & Co 	PKC Roads team

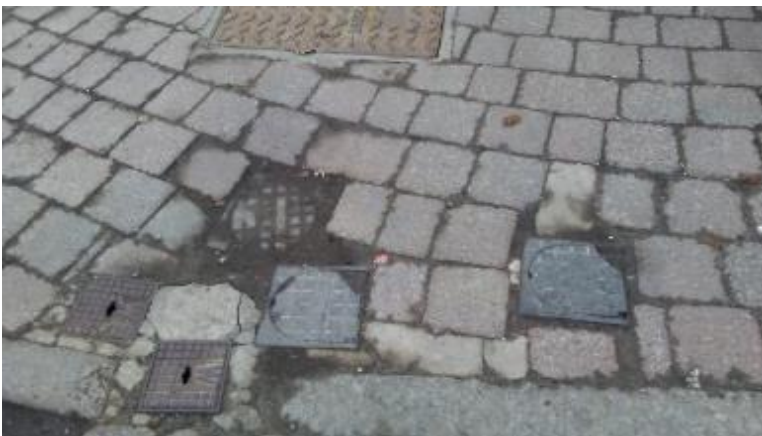
Poor footway at entrance to Fisher's Hotel car park

The join between the footway and the car park entrance is not smooth and could be a trip hazard for pedestrians. The kerb area in front of the Honest Thistle that edges with the car park entrance is also poorly maintained.

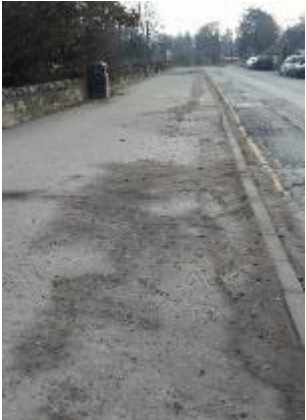
Atholl Rd outside Baptist Church	Poorly maintained footway on the near side.	Trip hazard for people with poor mobility.	Footway surfaces and obstructions	Resurface footway

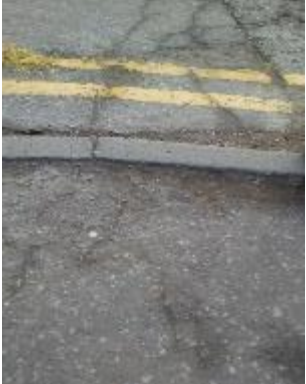
Crossing at entrance to information centre.	Poor kerbs and surface maintenance on footway and carriageway.	Difficult to cross if you have mobility issues	Footway surfaces and obstructions	Upgrade surface and add dropped kerbs.

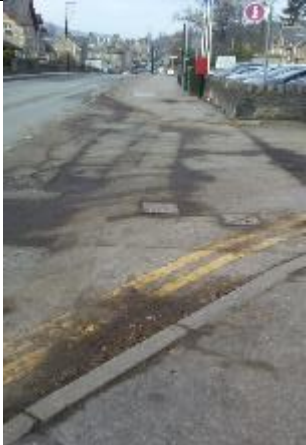
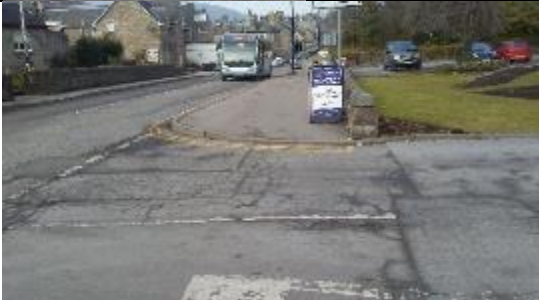
<p>Crossing at Car Park entrance near Tourist Information</p>	<p>Dropped kerbs, wide footway, A board on footway</p>	<p>Difficult to cross if you have mobility issues</p>	<p>Footway surfaces and obstructions</p>	<p>Upgrade surface.</p>

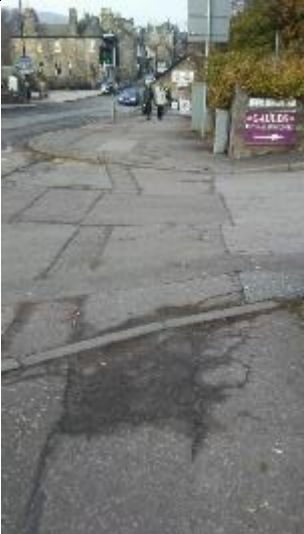
<p>Crossing Elm Court access lane</p>	<p>Poor kerb and surface maintenance</p>	<p>Difficult to cross if you have mobility issues</p>	<p>Footway surfaces and obstructions</p>	<p>Upgrade surface and add dropped kerbs.</p>

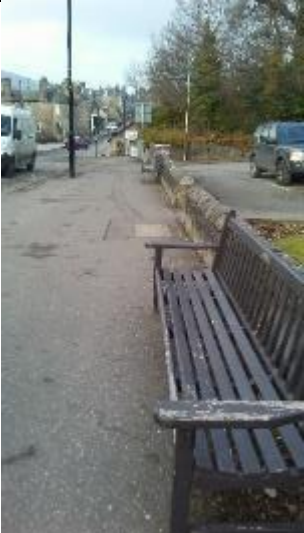
<p>Atholl Road near car park</p>	<p>Seating with arms</p>	<p>Good place to rest</p>	<p>Facilities and signage</p>

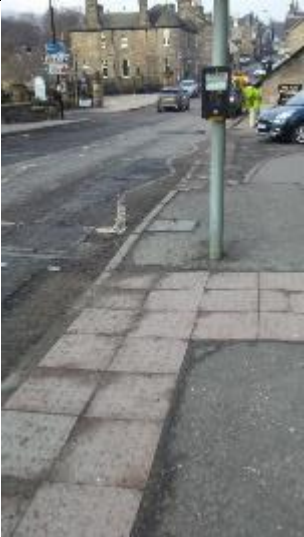
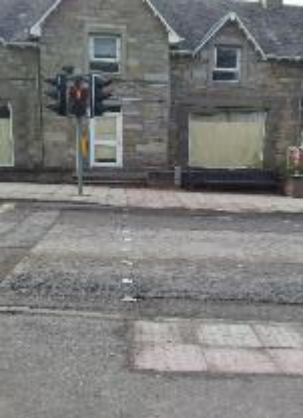
<p>Pedestrian crossing Atholl Road, near Elm Court.</p>	<p>Good crossing with tactile paving, but carriageway in poor repair</p>	<p>Crossing point good but poor surface on carriageway could be a trip hazard, bumpy for wheelchair users</p>	<p>Crossing points and desire lines</p>	<p>Resurface carriageway</p>

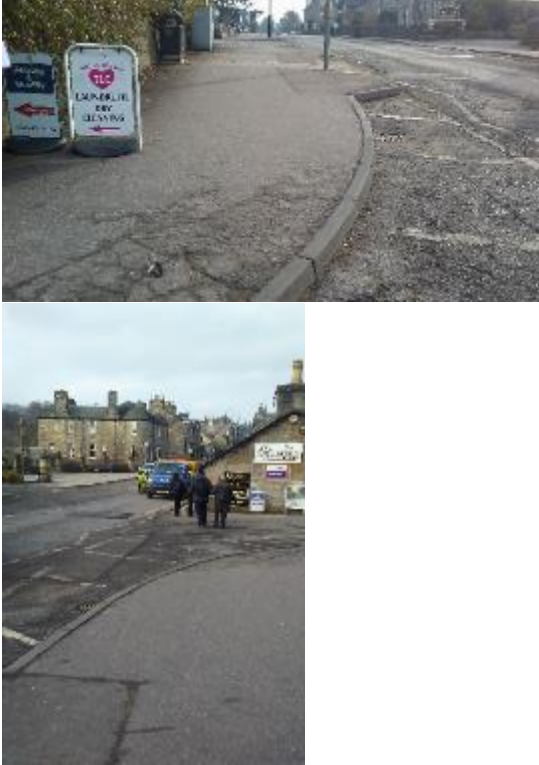
<p>Footway and entrance to Atholl Road Business Centre</p> <p>Footway and entrance to Atholl Road Business Centre</p>	<p>Corner at an odd angle with dropped kerb close to business centre away from carriageway. Poor surface condition.</p> <p>Corner at an odd angle with dropped kerb close to business centre away from carriageway. Poor surface condition.</p>	<p>Pedestrians have to cross at an angle and due to road surface, this can cause a trip hazard.</p> <p>Pedestrians have to cross at an angle and due to road surface, this can cause a trip hazard.</p>	<p>Footway surfaces and obstructions</p> <p>Footway surfaces and obstructions</p>	<p>Repair the carriageway surface</p> <p>Repair the carriageway surface</p>

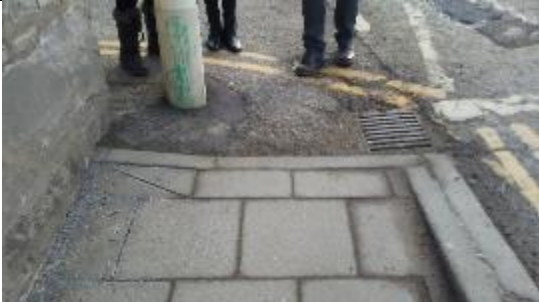
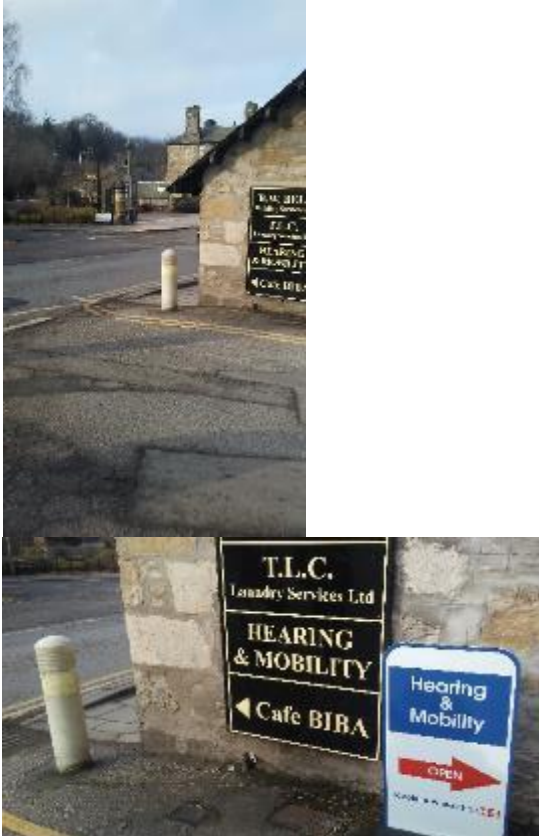
Corner at hardware store at entrance to Business Centre	Bollard and drain partially blocking footway at the hardware shop.	Bollard and drain make it tricky to get back on to the footway at the shop.	Footway surfaces and obstructions	Remove bollard or move slightly to be less obstructive.

<p>Corner at hardware store at entrance to Business Centre</p>	<p>Bollard and drain partially blocking footway at the hardware shop.</p>	<p>Bollard and drain make it tricky to get back on to the footway at the shop.</p>	<p>Footway surfaces and obstructions</p>	<p>Remove bollard or move slightly to be less obstructive.</p>

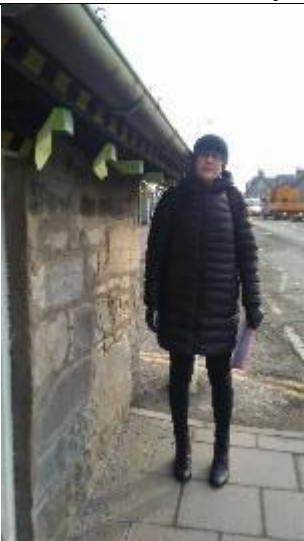
<p>Corner at hardware store at entrance to Business Centre</p>	<p>Low roofline partially blocking footway at the hardware shop.</p>	<p>Low roofline it is tricky to get back on to the footway at the shop.</p>	<p>Footway surfaces and obstructions</p>	<p>Highlight the low roofline.</p>

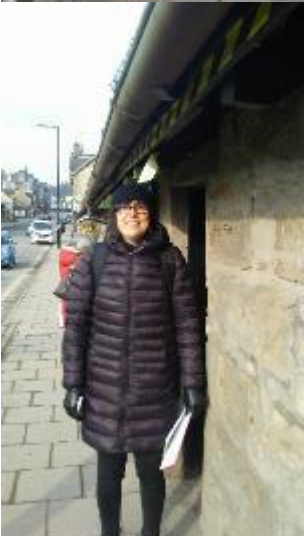
<p>Corner at hardware store at entrance to Business Centre</p>	<p>Low roofline partially blocking footway at the hardware shop.</p>	<p>Low roofline it is tricky to get back on to the footway at the shop.</p>	<p>Footway surfaces and obstructions</p>	<p>Highlight the low roofline</p>

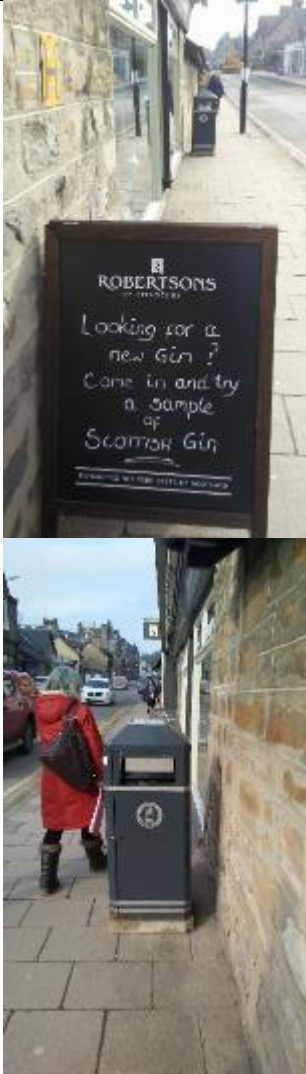
<p>A boards south end of Atholl Road</p>	<p>Several A boards along the length of the street</p>	<p>Narrows footway and causes an obstruction making it difficult for those with poor mobility or visual impairment.</p>	<p>Footway surfaces and obstructions</p>	<p>Removal of A boards</p>

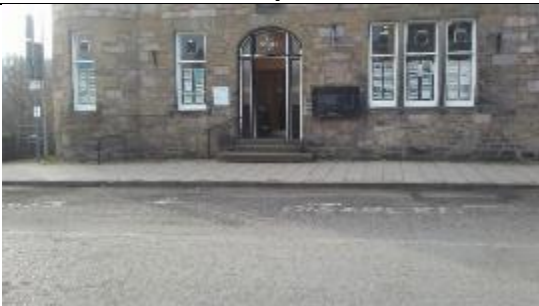
Atholl Road opposite Robertsons of Pitlochry	Disabled parking bay, painted markings are fading	Helpful for pedestrians to access the High Street shops	Facilities and signage	Repainting disabled space

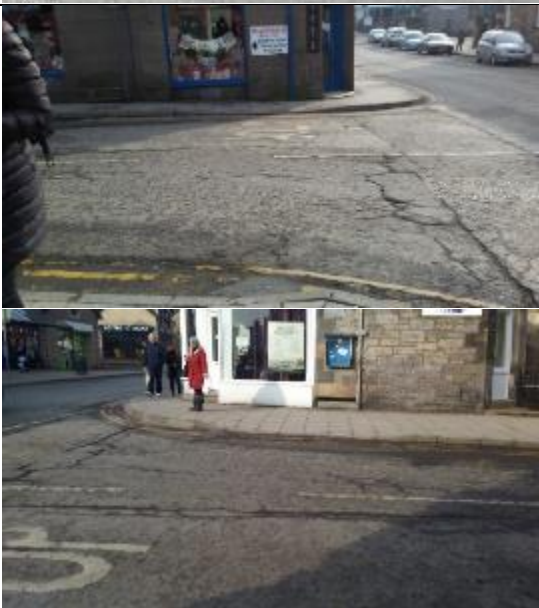
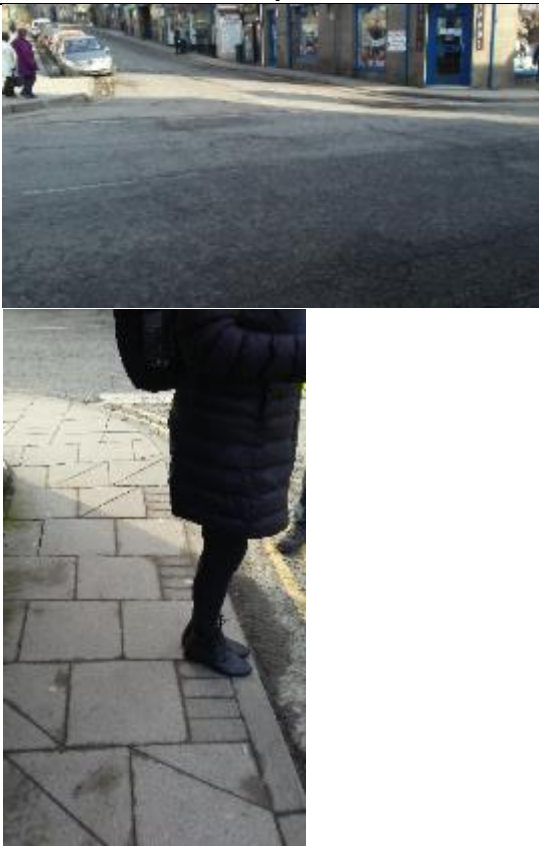
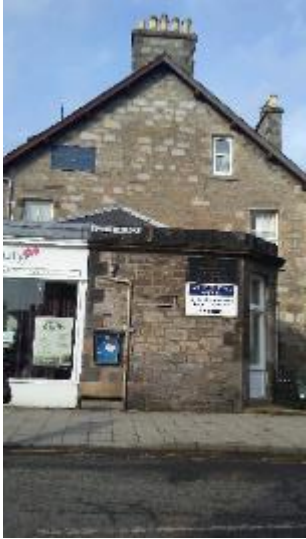
Crossing Bonnethill Road	Footway at Cards and Co is narrow. Dropped kerbs on each side aren't lined up. Carriageway in poor repair.	The narrow footway could make it difficult for wheelchair users to manoeuvre to cross. Wheelchair and mobility aid users have to walk further at an angle.	Crossings and desire lines	Line up dropped kerbs, resurface carriageway

<p>Crossing Bonnethill Road</p>	<p>Footway at Cards and Co is narrow. Dropped kerbs on each side aren't lined up. Carriageway in poor repair.</p>	<p>The narrow footway could make it difficult for wheelchair users to manoeuvre to cross. Wheelchair and mobility aid users have to walk further at an angle.</p>	<p>Crossings and desire lines</p>	<p>Line up dropped kerbs, resurface carriageway</p>

Crossing Bonneathill Road	Footway at Cards and Co is narrow. Dropped kerbs on each side aren't lined up. Carriageway in poor repair.	The narrow footway could make it difficult for wheelchair users to manoeuvre to cross. Wheelchair and mobility aid users have to walk further at an angle.	Crossings and desire lines	Line up dropped kerbs, resurface carriageway

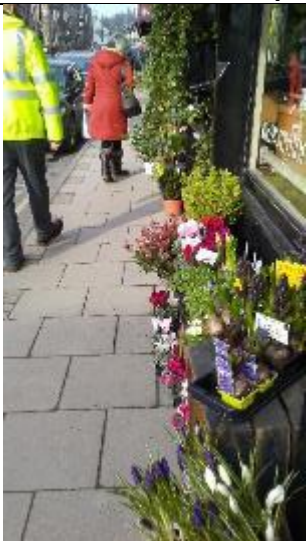
Atholl Road Williamson's florists.	Lots of shelving and plants/flowers outside the shop.	Plants narrow the usable footway this can be problematic for people with mobility issues	Footway surfaces and obstructions	Remove or reduce street furniture.

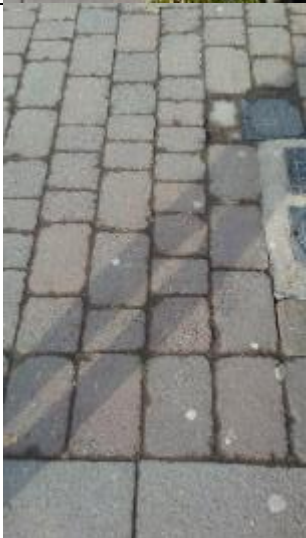
Driveway beside Love your sweets	Raised driveway to footway level	Easy to cross if you are a wheelchair user but could be difficult to distinguish for people with visual impairment	Footway surfaces and obstructions	Use colour to differentiate footway and driveway

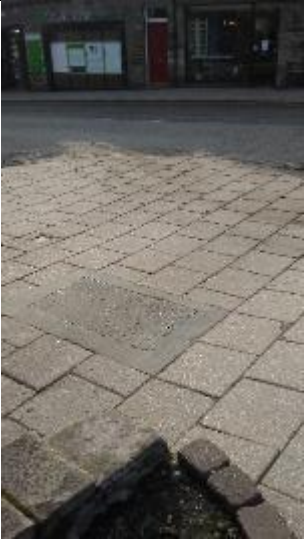
Atholl Road, build out beside Bank of Scotland	Circular build out between bus stop and parking bays, also access to rear of the bank.

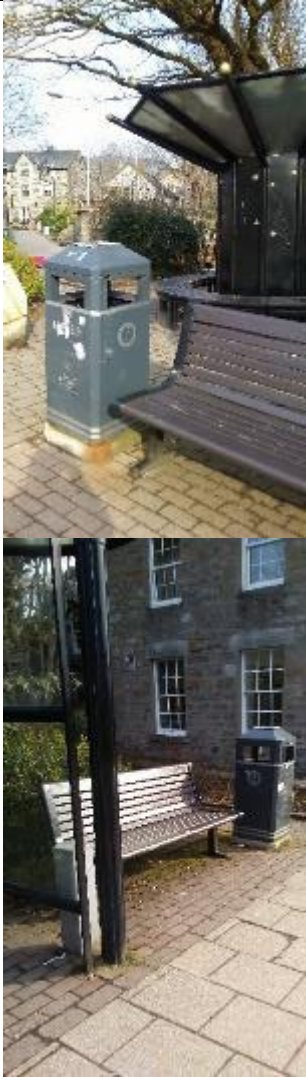
<p>Bus stop on Atholl Road</p>	<p>Seating, litter bins, bus information, community notice boards</p>	<p>Lots of useful information and seating if waiting for the bus. Seating set back from footway so waiting passengers should not cause obstruction to pedestrians</p>	<p>Signage and facilities</p>

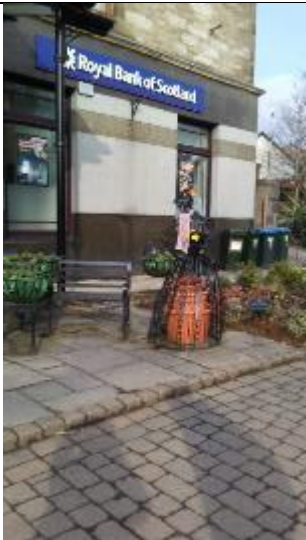
Atholl Road, beside RBS	Artwork, flower beds and seating	Nice area with points of interest	Aesthetics, facilities and signage

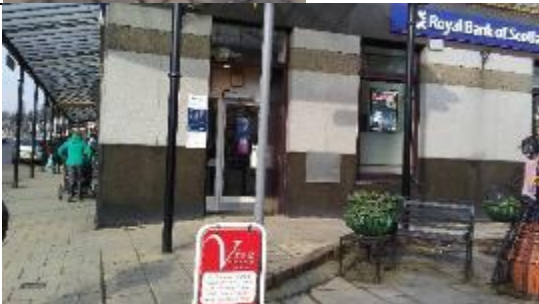
Atholl Road beside RBS	Arcade covering starts, poles situated on edge of footway and are painted black for good contrast.	Poles are well situated and have good contrast for visually impaired. Good space for pedestrians.	Facilities and signage

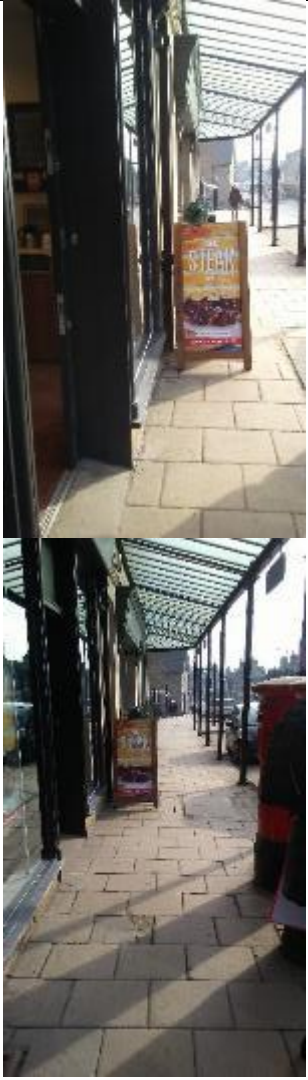
<p>A boards in the arcade area</p>	<p>A board situated near Greggs entrance and post boxes</p>	<p>A board narrows footway, if it was situated at the other side of the shop entrance it would be slightly less of an obstruction.</p>	<p>Footway surfaces and obstructions</p>	<p>Move or remove A board</p>

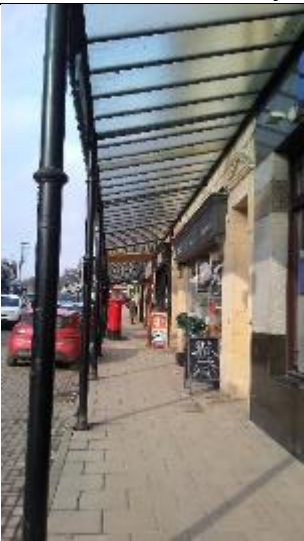
<p>A boards in the arcade area</p>	<p>A board situated near Greggs entrance and post boxes</p>	<p>A board narrows footway, if it was situated at the other side of the shop entrance it would be slightly less of an obstruction.</p>	<p>Footway surfaces and obstructions</p>	<p>Move or remove A board</p>

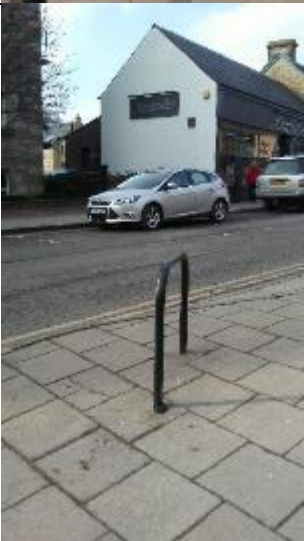
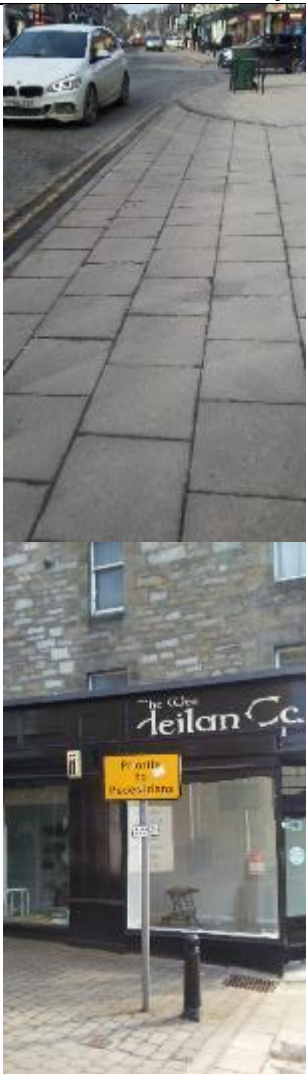
<p>Atholl Road near Heilan Café at the end of Mill Lane</p>	<p>Build out from the lane, bike racks at each side and raised rounded kerbs. Priority to pedestrian area (signed)</p>	<p>This is a wide space but could cause difficulty in navigation especially if bike racks are full. Could be a trip hazard. Also the round kerb edges can be confusing for the visually impaired. Otherwise a nice wide space.</p>	<p>Footway surfaces and obstructions</p>	<p>Level out rounded kerbs to reduce confusion and trip hazard</p>

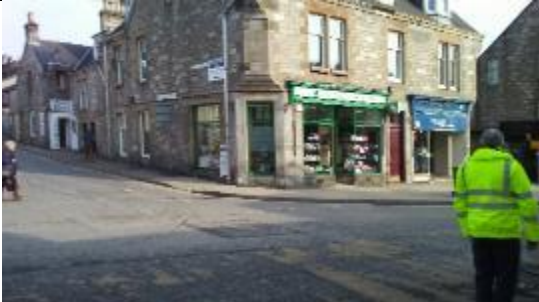
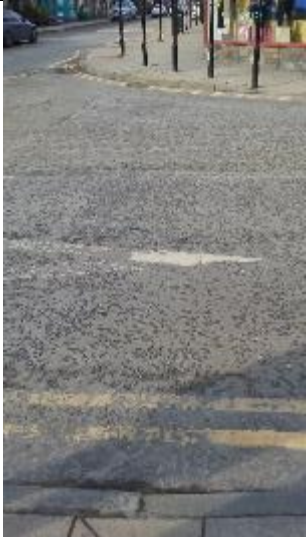
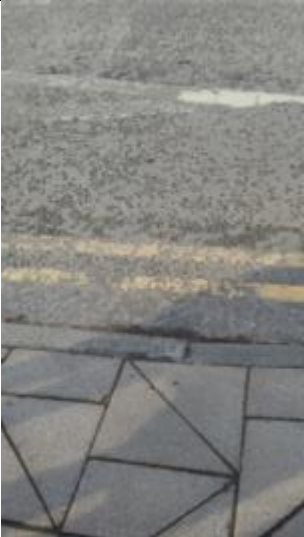
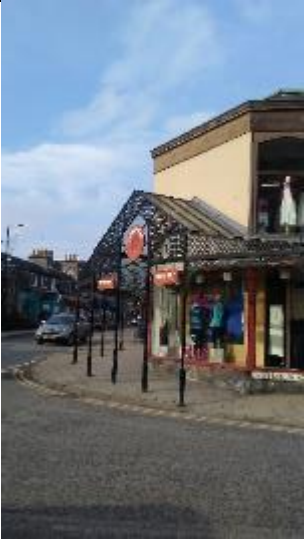
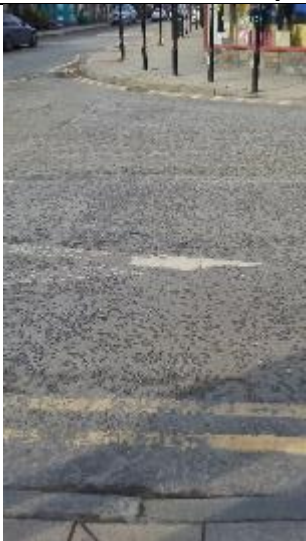
<p>Junction with West Moulin Road and Atholl Road</p>	<p>Busy junction leading to Coop. Dropped kerbs do not line up, also in poor condition and there is an arcade pole causing obstruction</p>	<p>Very difficult to cross road if you use mobility scooter or wheelchair, pedestrians often cross atholl road at chemist rather than at the crossing further north</p>	<p>Crossing points and desire lines</p>	<p>Improve dropped kerbs on West Moulin Road. Possibly make it a signalised crossing on 3 road points to junction</p>

Junction with West Moulin Road and Atholl Road	Busy junction leading to Coop. Dropped kerbs do not line up, also in poor condition and there is an arcade pole causing obstruction	Very difficult to cross road if you use mobility scooter or wheelchair, pedestrians often cross atholl road at chemist rather than at the crossing further north	Crossing points and desire lines	Improve dropped kerbs on West Moulin Road. Possibly make it a signalised crossing on 3 road points to junction

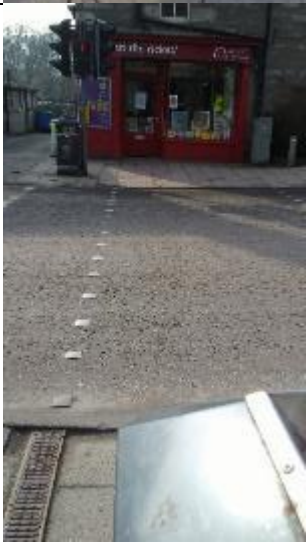
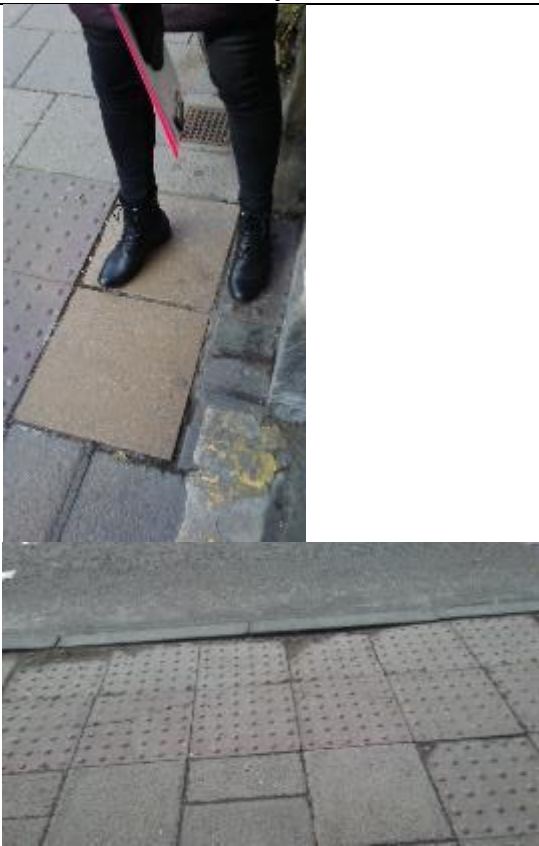
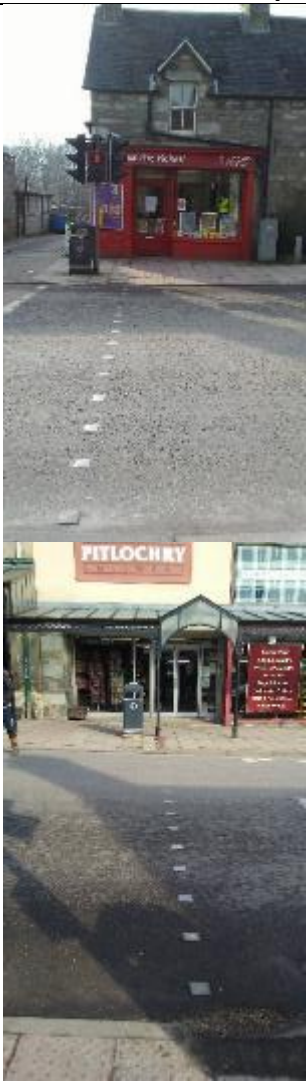
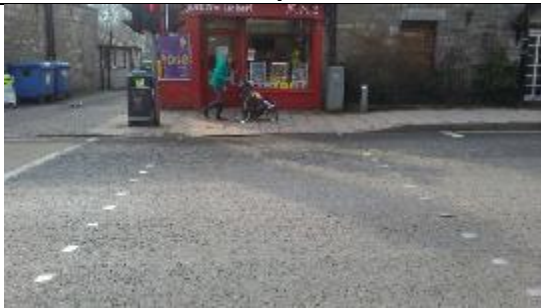
<p>Pedestrian crossing on Atholl Road at Pitlochry Knitwear</p>	<p>Missing tactile paving at wall, Litterbin situated in the direct line of the tactile paving. Dropped kerb in poor repair.</p>	<p>Difficult to cross if you are visually impaired. Also difficult to cross if you have a mobility issue.</p>	<p>Crossing points and desire lines</p>	<p>Replace tactile paving. Move litterbin to other side of the pole. Replace/fix dropped kerb</p>

Pedestrian crossing on Atholl Road at Pitlochry Knitwear	Missing tactile paving at wall, Litterbin situated in the direct line of the tactile paving. Dropped kerb in poor repair.	Difficult to cross if you are visually impaired. Also difficult to cross if you have a mobility issue.	Crossing points and desire lines	Replace tactile paving. Move litterbin to other side of the pole. Replace/fix dropped kerb
	Arcade near pedestrian crossing at Morton's	Tables, chairs and A boards outside Morton's Café, these can take up a lot of space when people are seated.	These can be an obstacle to pedestrians	Footway surfaces and obstructions	Check they have planning permission for tables and ensure they are not taking up too much room

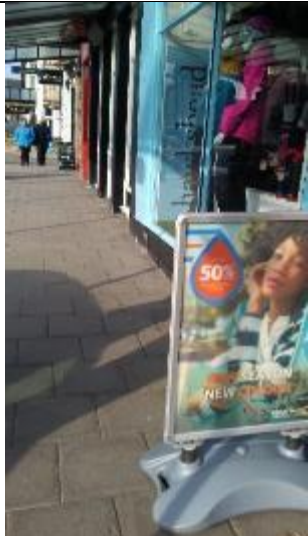
Atholl Road between pedestrian crossing and Birnam Place	A boards	Trip hazard	Footway surfaces and obstructions	Remove A boards

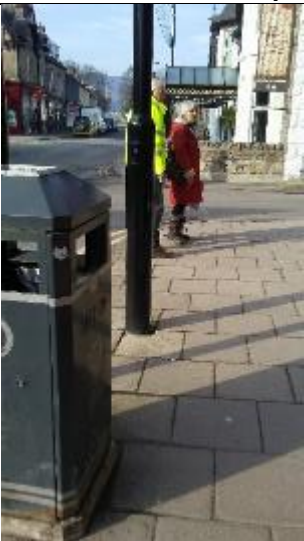
Arcade towards Birnam Place	Good sightlines for visually impaired, Litterbin and poles on the side	Good for pedestrians	Footway surfaces and obstructions

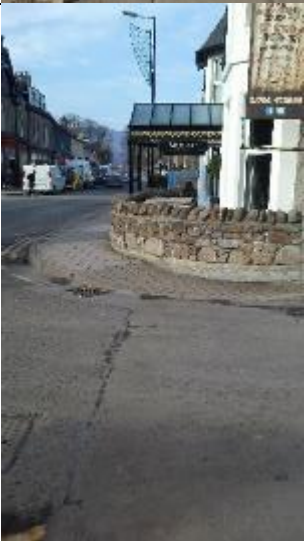
Crossing Birnam Place	Good dropped kerbs, footway quite narrow on Mackays Hotel side	Could be difficult for wheelchair or mobility scooter users to manoeuvre onto and around footway	Crossing points and desire lines	Widen footway

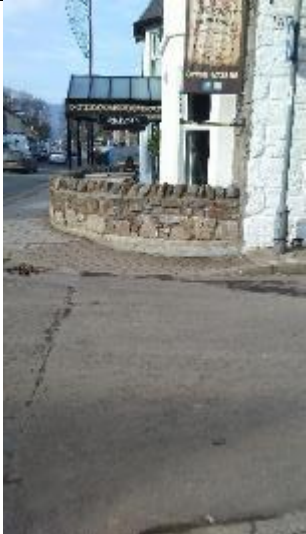
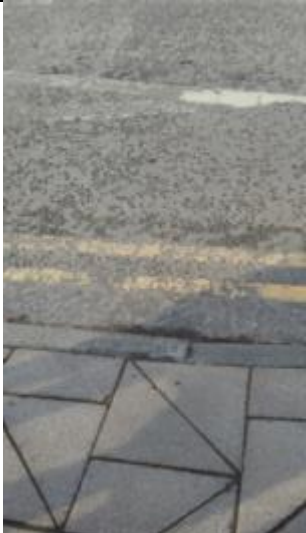
<p>Crossing Birnam Place</p>	<p>Good dropped kerbs, footway quite narrow on Mackays Hotel side</p>	<p>Could be difficult for wheelchair or mobility scooter users to manoeuvre onto and around footway</p>	<p>Crossing points and desire lines</p>	<p>Widen footway</p>

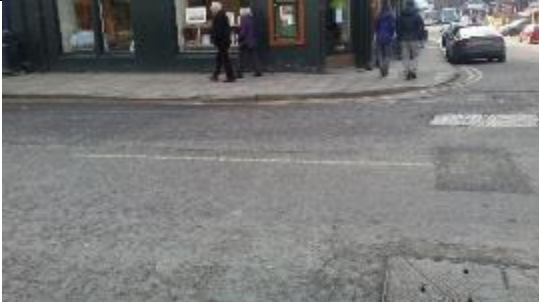
Corner Atholl Road and Station Road	Dropped kerbs but south side is very narrow	Could be difficult to remount the footway at southside with narrow dropped kerb if you are a wheelchair, pushchair or mobility scooter user.	Crossing points and desire lines	Extend dropped kerb on the south side of the road

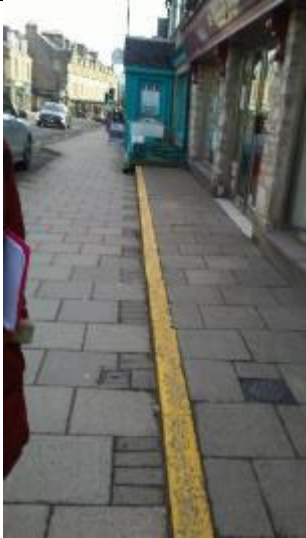
Atholl road at the Edinburgh Woollen Mill	Raised portion of the footway/ramp to shop entrance. Is painted yellow	Could be a trip hazard especially for the visually impaired.	Footway surfaces and obstructions	Repaint the yellow edging.

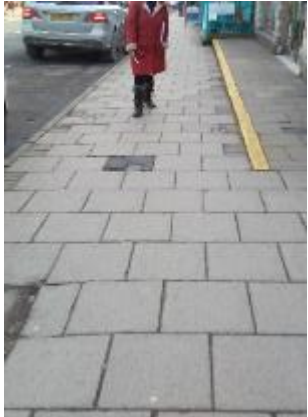
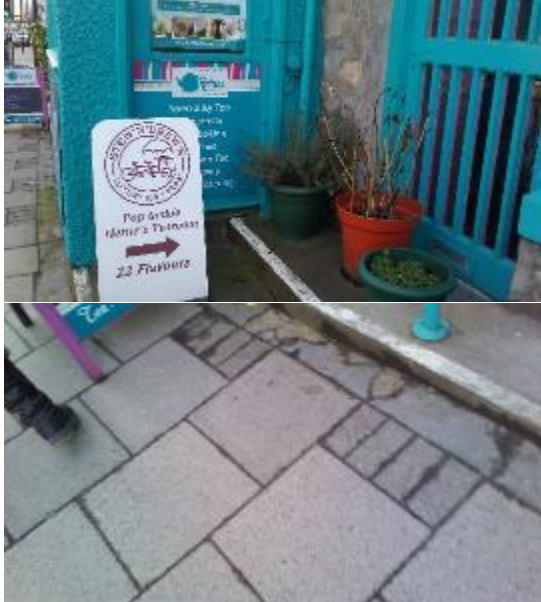
<p>Hetties Tearoom on Atholl Road</p>	<p>Confusing signage and plants on steps to false door. Also Aboard and steps to actual entrance. There is a handrail and the step edges have been highlighted in white paint.</p>	<p>Handrail at entrance good for less mobile.</p>	<p>Facilities and signage</p>	<p>Remove A boards, repaint the steps. Make clear which door is the actual entrance.</p>

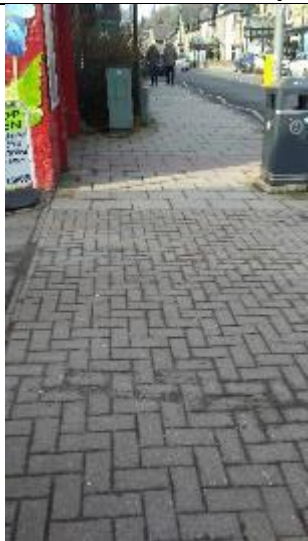
<p>Level with footway drive near crossing at arcade</p>	<p>Access lane level with footway,</p>	<p>Good for wheelchair, pushchair, mobility scooter users. This could be confusing for visually impaired if cars moving across it</p>	<p>Footway surfaces and obstructions</p>	<p>Use colour to show different/dual usage</p>

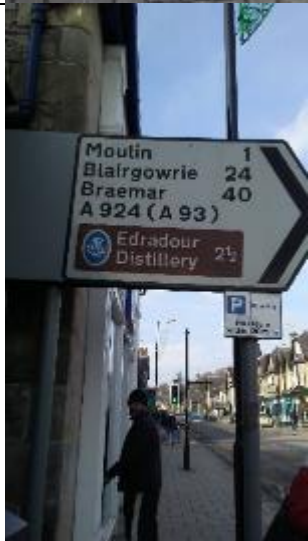
<p>Keepsakes on Atholl Road</p>	<p>Lamp post and sign posts partially blocking the footway. These are too big and too close to each other.</p>	<p>Causes obstruction to pedestrians also may make it difficult for wheelchair and mobility scooter users.</p>	<p>Footway surfaces and obstructions.</p>	<p>Rationalise signage and poles.</p>

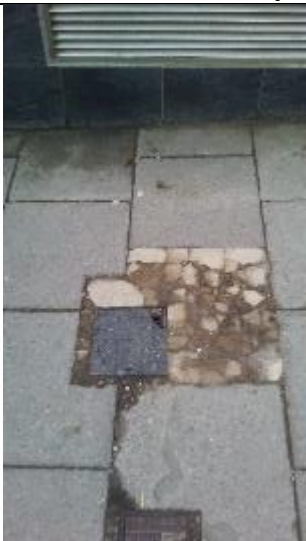
<p>Poor footway maintenance.</p>	<p>Trip hazard, especially for the less mobile.</p>	<p>Footway surfaces and obstructions</p>	<p>Repair the footway.</p>

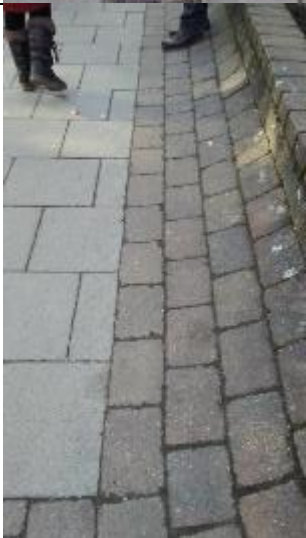
<p>Wall at Fisher's hotel</p>	<p>Edge of wall curves at the bottom.</p>	<p>Bevelled edge could be a trip hazard for less mobile and visually impaired</p>	<p>Footway surface and obstacles</p>	<p>Flatten footway at wall</p>

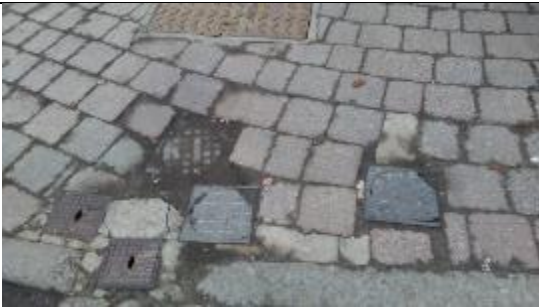
Fishers hotel car park entrance near Honest Thistle	Poor surface and manhole placement	Trip hazard for people with poor mobility	Maintenance and enforcement issues	Repair footway, resetting manhole covers
