Living Streets

Community Street Audit Report

Pitlochry
March 2018

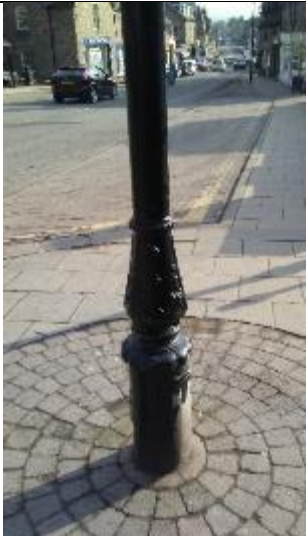
Clock on post and seating area outside Fisher's Hotel	The Clock post is situated in the middle of the footway and covered seating is nearby closer to the hotel side of the footway.	This could be confusing for the visually impaired and can cause an obstruction to pedestrians	Aesthetics, footway surfaces and obstructions

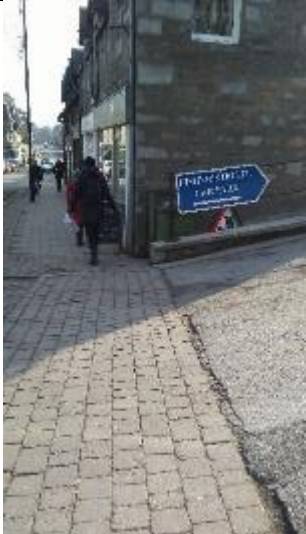
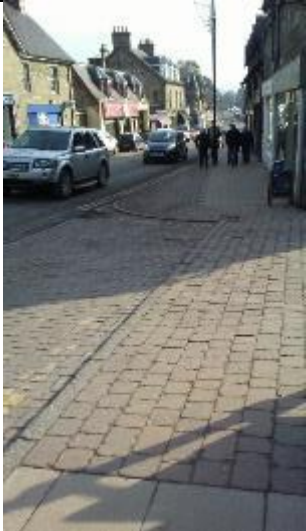
Entrance to Fishers Hotel car park	Poorly maintained footway especially at join between cobbles and tarmac. Level with footway on either side.	Could be trip hazard for pedestrians. Raised road could cause confusion for visually impaired	Footway surfaces and obstacles	Repair footway, have better contrast footway from drive.

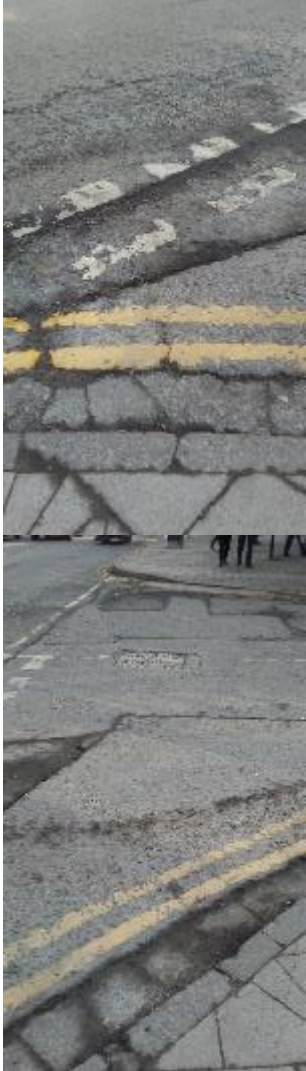
Barnardos, Burnside Road	Poor kerbs, footway and carriageway, bad camber	Difficult to cross if you have mobility issues	Footway surface and obstacles	Repair footway and carriageway

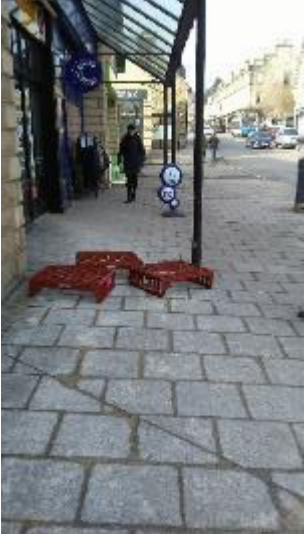
Premier on Atholl Road	Several obstacles, A boards, Cones, Bread pallets. Post office now in Premier	Obstacles for pedestrians	Footway surface and obstacles	Clear away obstacles from footway

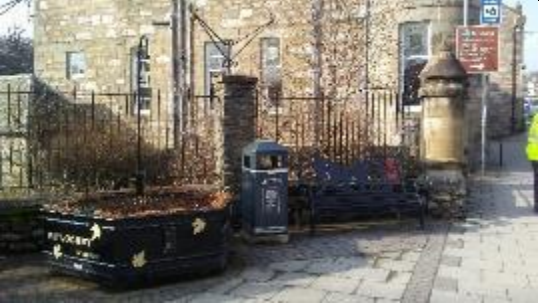
Atholl Road War Memorial	Decorative seating, monument and gardens. Open space and litterbins	Good space to linger, with seating and raised flower beds.	Aesthetics, facilities and signage

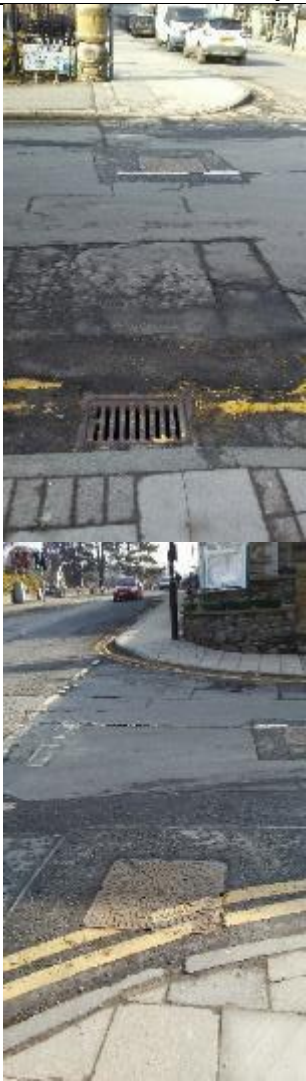
Atholl Road and Ferry Road junction and crossing	Poor dropped kerbs, not aligned and footway/carrageway maintenance. The footway on the Victorias side of the road is narrow at an angle with a steep camber.	Difficult road to cross for wheelchair users or elderly. Route to and from Community hospital, GP and Care Home in addition to car parks, so possibly busy route.	Crossing points and desire lines.	Widen footway on Victoria's side

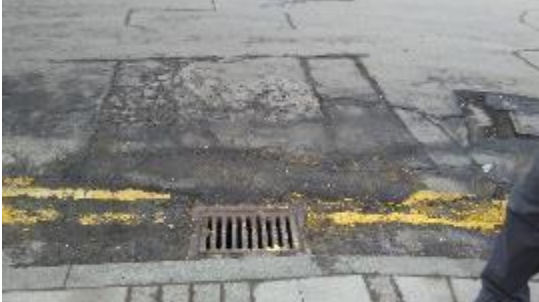
Atholl Road and Ferry Road junction and crossing	Poor dropped kerbs, not aligned and footway/carrageway maintenance. The footway on the Victorias side of the road is narrow at an angle with a steep camber.	Difficult road to cross for wheelchair users or elderly. Route to and from Community hospital, GP and Care Home in addition to car parks, so possibly busy route.	Crossing points and desire lines.	Widen footway on Victoria's side

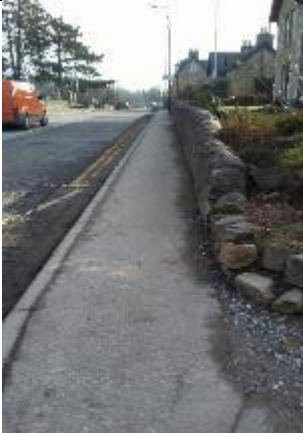
Atholl Road near the Atholl Centre	Narrow footway	Could be difficult for wheelchair, mobility scooter users.	Road layout and space allocation	Widen footway
