# Living Streets

## Community Street Audit Report

Coupar Angus  
March 2018

## **Background to Coupar Angus Community Street Audit audit**

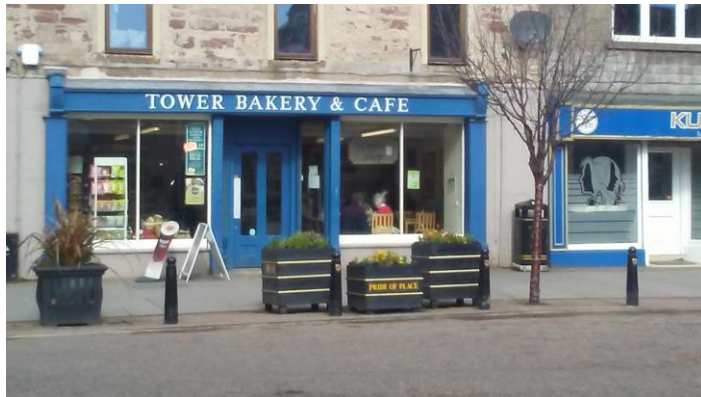
The space on Union Street between George Square and Commercial Street has recently been upgraded. It has a well maintained footway and flower planters that add to the look and feel of this area.

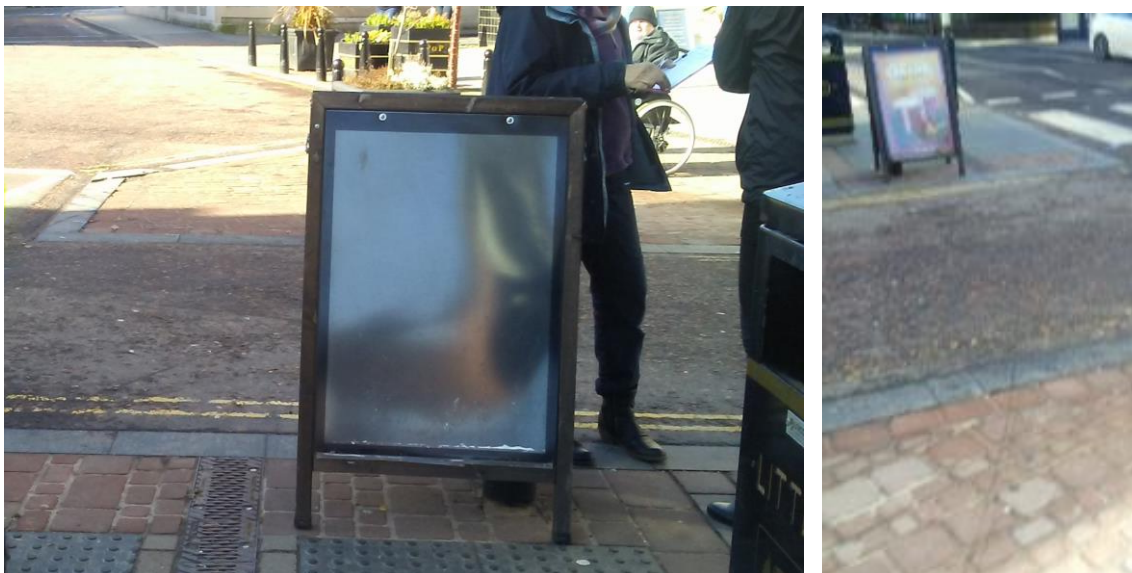
- There were several advertising boards on the footway along Union Street from the zebra crossing to George square. These reduced the space for pedestrians and could be a trip hazard especially for visually impaired pedestrians. This was especially true of one board placed on the tactile paving near the zebra crossing and a junction, and the board was blank on one side.

Advertising board on Union Street

Area/Issue	Recommended Action	Level of Action Quick Win/ long Term	Responsibility/ Involvement
1 - Obstructions	1 – Speak to business owners about advertising board guidelines and the potential difficulties they pose for the less able. 2 – Wheelie bins blocking footways, ensure these are left not blocking the footway. 3 – Work with road maintenance workers to ensure that signs are not obstructing the footways and the difficulties they pose for the less able. 4 – Replace the 30mph bollard on Burnside Road with a taller speed sign, placed further to the edge of the footway.	1 – Quick win 2 – Medium term 3 – Medium term 4 – Medium term	PKC and business owners
2 – Footway Surfaces (maintenance)	1 – Repair the footway surface leading from George Square to Causewayend. 2 – Repair the footway along Causewayend. 3 – Repair the footway on Station Road near the junction with Union Street. 4 – Repair the footway on Union Street near the junction with Station Road. 5 – Repair the footway and carriageway on Victoria Street.	1 – Medium term 2 – Medium term 3 – Medium term 4 – Medium term 5 – Medium term	PKC

Action	Responsibility
Work with refuse collection teams to educate staff to ensure bins aren't left blocking footways.	PKC Roads team
Removal of badly placed advertising boards and street furniture, giving guidelines and information to business owners.	PKC Roads team and business owner
Work with road maintenance teams to educate staff to ensure road signs aren't left blocking footways.	PKC Roads team
Remove the 30mph bollard on Burnside Road and replace it with a taller 30mph sign, closer to the edge of the footway.	PKC Roads team
Repair the footway surface leading from George Square to Causewayend.	PKC Roads team
Repair the footway along Causewayend.	PKC Roads team
Repair the footway on Station Road near the junction with Union Street.	PKC Roads team
Repair the footway on Union Street near the junction with Station Road.	PKC Roads team
Repair the footway and carriageway on Victoria Street.	PKC Roads team

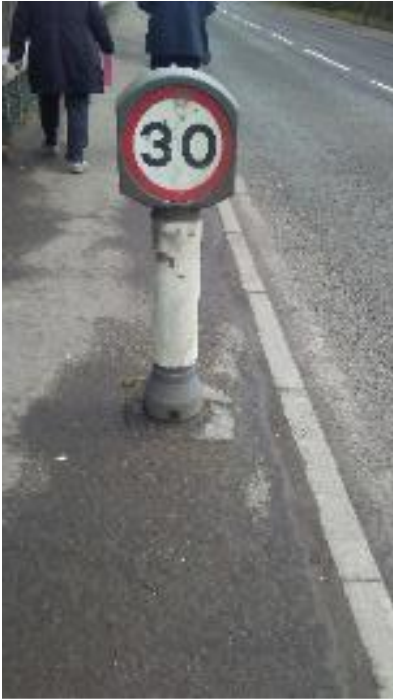
- There is a short 30mph sign on a bollard on the footway on Burnside Road. This obstructs the footway and is a trip hazard for pedestrians. As it is low and fairly small it will also be less visible to drivers.

30mph bollard on Burnside Road

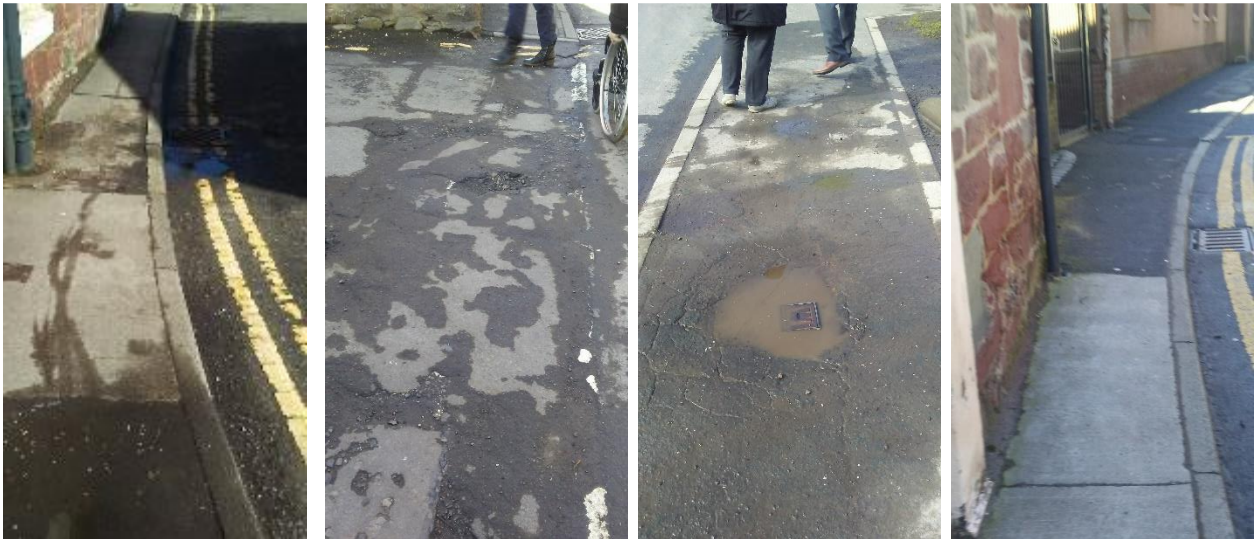
- The footways in George Square, along Causewayend, Athole Street and Commercial Street are very narrow and would only allow a single pedestrian to walk along them at a time. The auditor that was in a wheelchair had to travel along the carriageway as the footway was too narrow to accommodate the wheelchair. The footways were also in a state of poor repair and some areas would be a trip hazard for pedestrians. On heading west along Causewayend there were telegraph poles situated in the middle of the narrow footways.

Footways along George Square and Causewayend

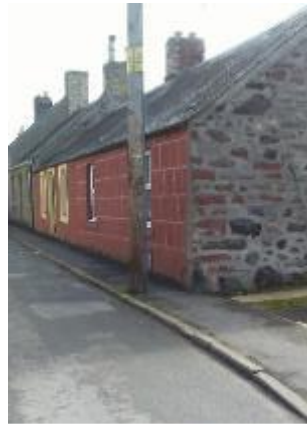
Telegraph poles along Causewayend

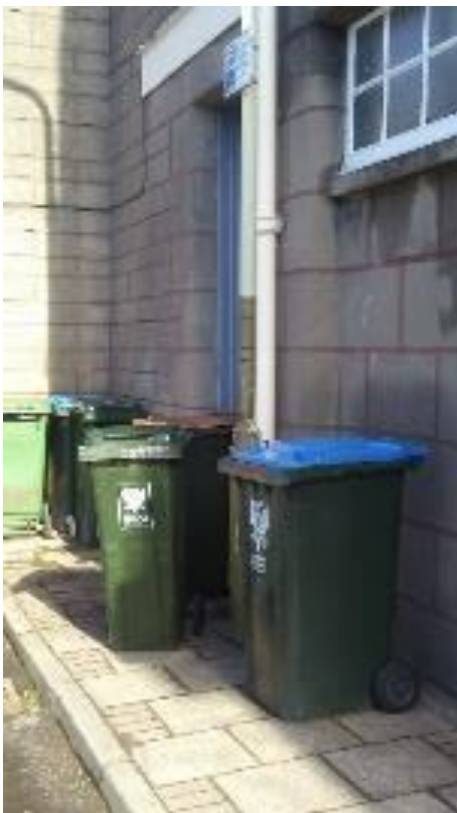
- The space in George Square has been recently upgraded. The footways are well maintained but there is only one dropped kerb at the amenity housing. When on the audit there was a car parked across the dropped kerb blocking the entrance to the housing. There were also wheelie bins obstructing the footway.

Wheelie bins on footway

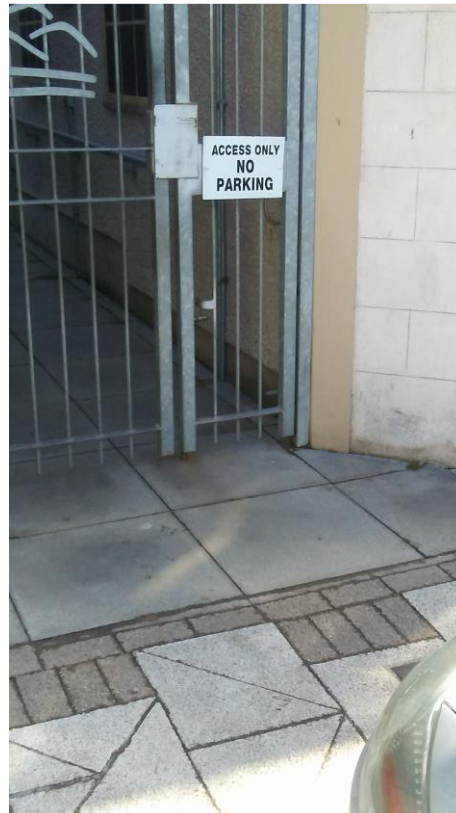
Car parked across dropped kerb and entrance

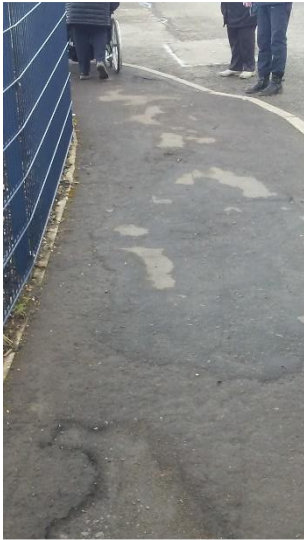
- At the end of Station Road at the junction with Union Street the footways are in a poor state of repair. They are a trip hazard, especially for less mobile pedestrians. In addition, there was a roadworks sign obstructing the footway along Station road. The auditor using a wheelchair was only just able to get past this sign.

Poor footway surface on Station Road

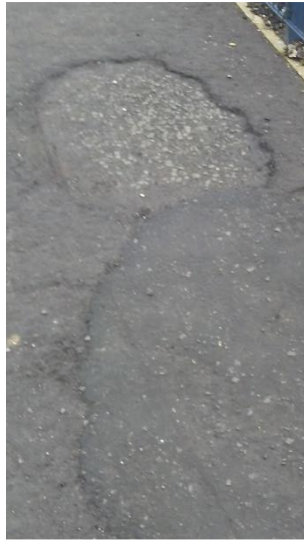
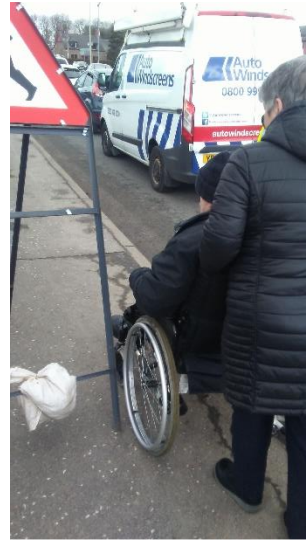
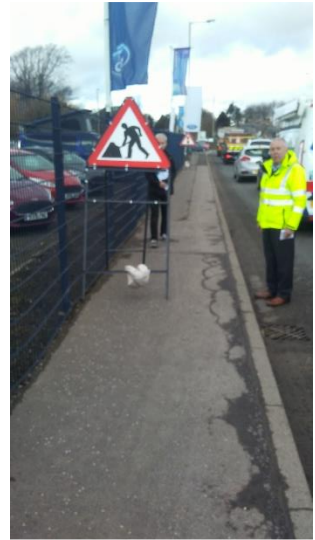
Roadworks sign obstructing footway on Station Rd

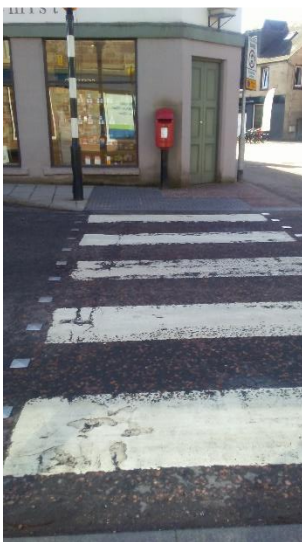
- The zebra crossing on Union Street, connects the corner shop on one side with the chemist on the other. There are speed bumps to the east of the crossing to slow approaching vehicles. Auditors said that the crossing was in the wrong place, people exiting and entering the shops were very close to the crossing and pedestrians waiting to cross as the footway was quite narrow. Auditors said they felt drivers approached the crossing at speed even with the speed bumps, one stated that she felt some larger vehicles sped up towards the speed bumps. Auditors felt the crossing should be further along George Street.

Zebra crossing

<b>Action</b>	<b>Responsibility</b>
Consult with the local community on the placement of the Union Street zebra crossing.	PKC Roads team

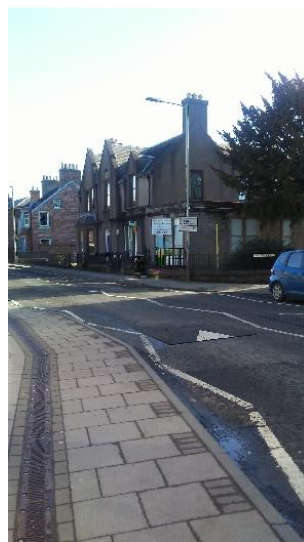
Speed bumps on Union St

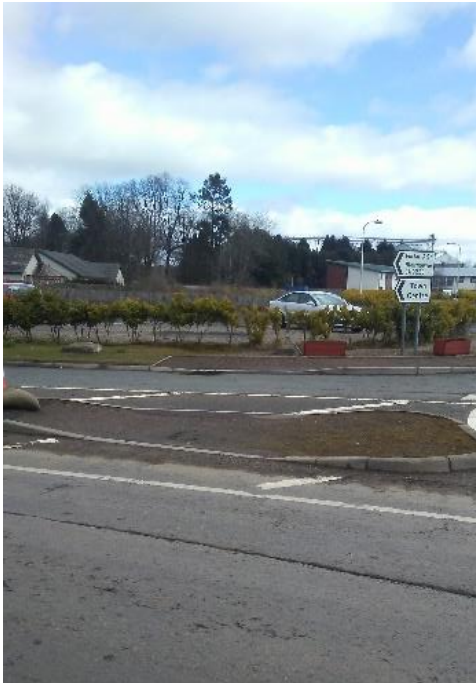
- The crossing point at the end of Station Road at the roundabout with Burnside Road is difficult if you are a wheelchair or mobility aid user. Crossing the road involves a narrow island, with dropped kerbs, in a busy road very close to a roundabout. This would be the main route for residents and visitors to the care home to access the town centre, so there may be several people with mobility aids or in wheelchairs trying to cross at one time. The volume of traffic is quite high, with a large proportion of heavy goods vehicles, which is intimidating and noisy, especially if the pedestrians are not able to move quickly. The crossing would be improved by increasing the island width or adding a zebra crossing.

Crossing island on Station Road

Area/Issue	Recommended Action	Level of Action Quick Win/ long Term	Responsibility/ Involvement
4 – Crossing Points	1 – Improve the crossing point on Station Road near the Balhousie Care Home, increasing the island width and adding a zebra crossing. 2 – Move the zebra crossing either further along Union Street or along George Street.	1 – Long term 2 – Long term	PKC
5 – Space allocation	1 – Add traffic priorities along Causewayend, Athole Street and Commercial Street and Hay Street, to encourage better movement of vehicles along these roads.	1 – Long term	PKC

Install dropped kerbs on Victoria Street, near to the junction with Union Street	PKC Roads team
Investigate options for improving the crossing point on Station Road near to the Balhousie Car Home	PKC Roads team

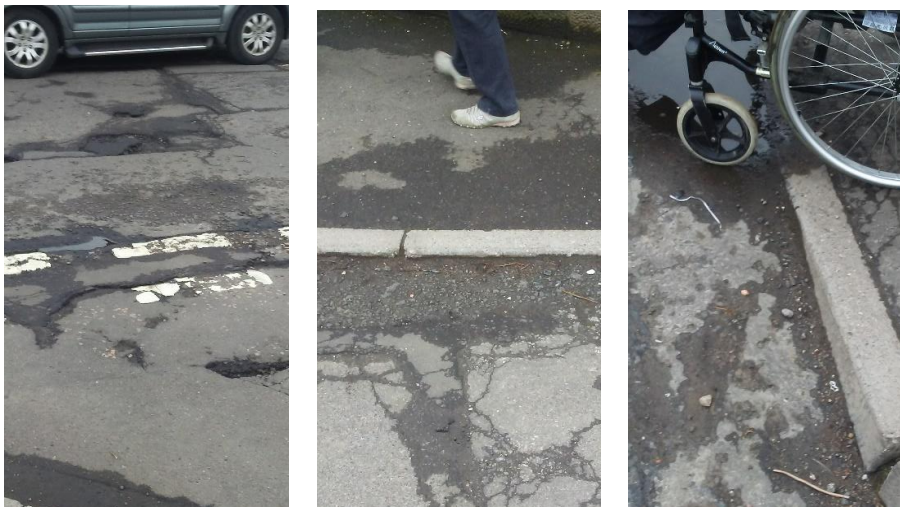
- Crossing Victoria Street is difficult for less mobile pedestrians, wheelchair and pushchair users due to the poor state of the footway and carriageway and the lack of an adequate dropped kerb. Victoria Road is adjacent to the Town Hall where there are several activities for elderly local residents.

Footway, Carriageway and dropped kerb at Victoria Road

3 – Footway Surfaces (dropped kerbs)	1 – Install a dropped kerb on Victoria Street near the entrance to the Town Hall.	1 – Medium term	PKC

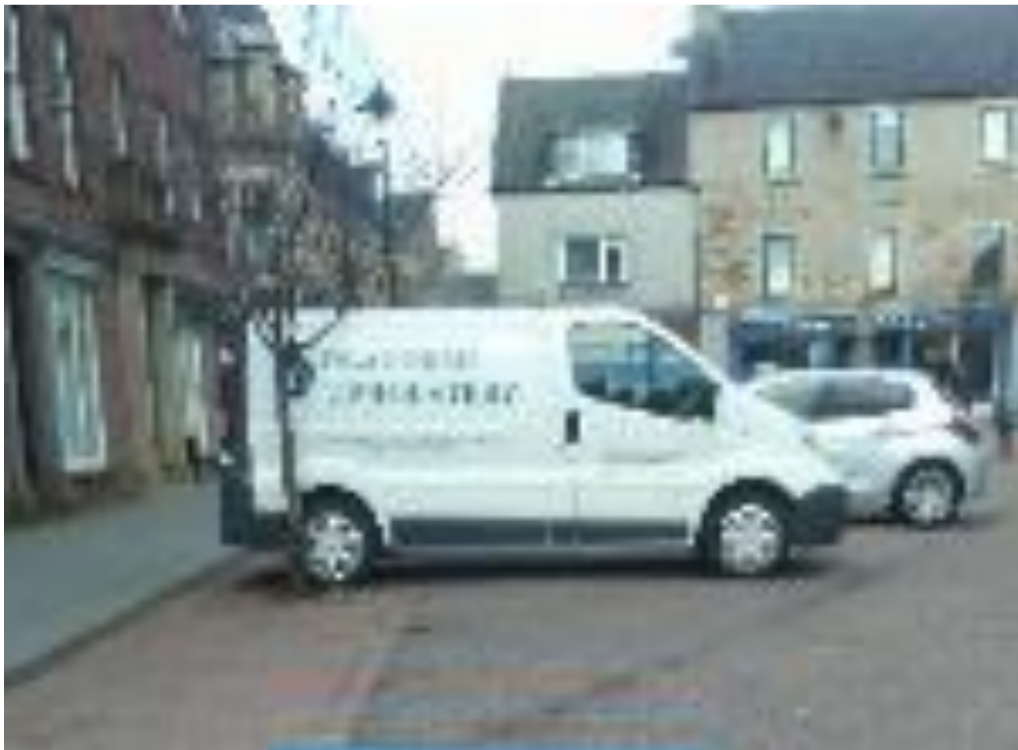
There were several cars parked in the pedestrian area of the High Street. There was confusion amongst the auditors as to whether or not vehicles were allowed in this area, and if they were, at what times and for how long. The signage showed that vehicles should only enter this area for loading. The vehicles we saw were obviously parked and not loading.

Vehicles parked in the pedestrian area.

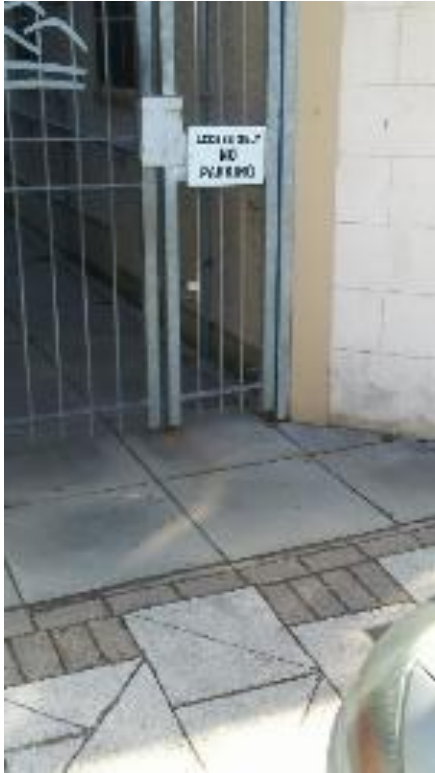
There was a car parked in the 'keep clear' area in front of the amenity housing in George Square, this blocked the dropped kerb. This obstructed the entrance to the housing and also stopped people with mobility issues from crossing George Square easily. Increased parking enforcement would help reduce parking in unsuitable spaces.

Parking in George Square in front of amenity housing access

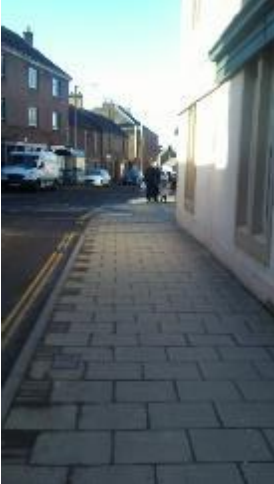
Union Street towards George Square	Wide well maintained footway	Good space to walk	Footway surfaces

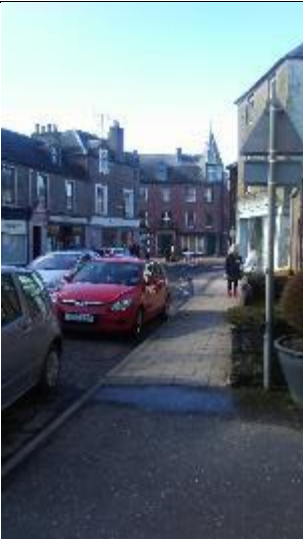
<p>Union Street towards George Square</p>	<p>Wide well maintained footway</p>	<p>Good space to walk</p>	<p>Footway surfaces</p>

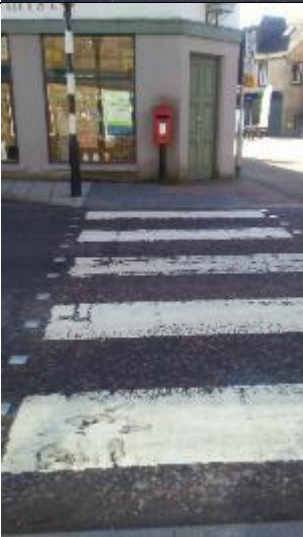
<p>Zebra crossing across Union Street between Chemist and Coop</p>	<p>Placement too close to shop entrances</p>	<p>Cars feel like they are travelling too fast towards the zebra crossing. Sometimes confusion as drivers are not sure if pedestrians exiting shops are planning to cross or not</p>	<p>Crossing points and desire lines</p>

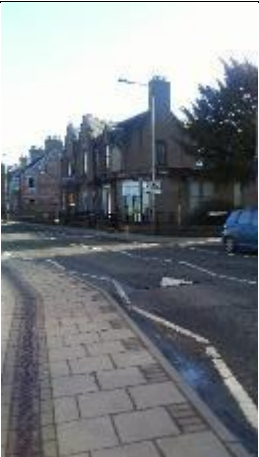
<p>Speed bumps on Union Street before zebra crossing</p>	<p>These are to slow down cars approaching the zebra crossing. Auditors felt that some cars sped up towards them</p> <p>One auditor that uses walking aids reported that he found them a trip hazard when crossing the road.</p>		<p>Crossing points and desire lines</p>

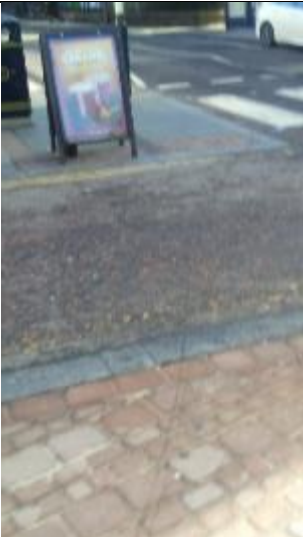
<p>A board on footway outside Coop at Commercial Street</p>	<p>Obstructs the footway outside the shop</p>	<p>Makes it difficult for pedestrians, especially if they are wheelchair or pushchair users</p>	<p>Footway surfaces and obstructions</p>

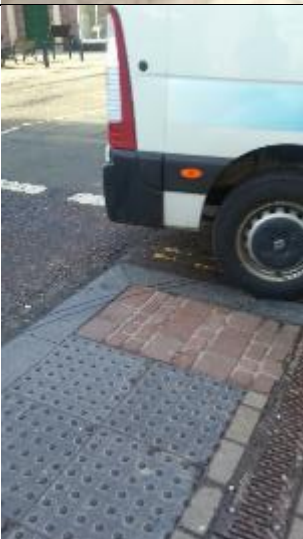
<p>Vehicle reversing off shared space paving, Commercial Street</p>	<p>Drove over tactile paving</p>	<p>Can be dangerous for pedestrians if they are not expecting vehicles to be moving in this space. The single level surface is good for wheelchair and mobility aid users, visually impaired pedestrians may find the area confusing to navigate</p>	<p>Footway surfaces, crossing point</p>

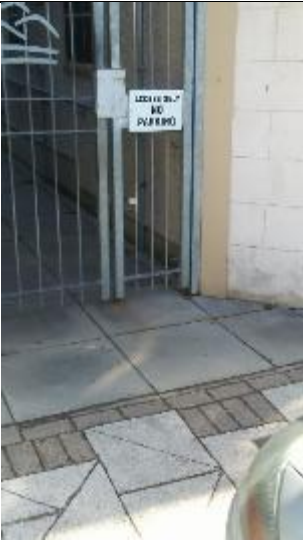
<p>In George Square, at amenity housing</p>	<p>Car was parked at dropped kerb at entrance, blocking it for wheelchair users</p>	<p>Obstruction for wheelchair users</p>	<p>Obstruction / enforcement</p>

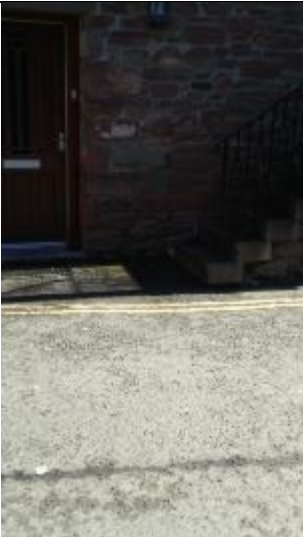
Steps to housing on George Square	Steps from carriageway to housing, lack of footway on east side of George Square	Makes walking on the East side difficult, as pedestrians are forced to walk on the carriageway.	Obstruction

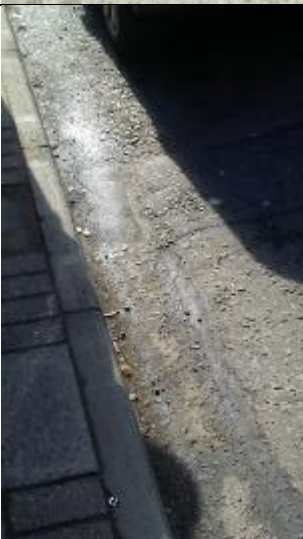
Kerb to parking spaces on George Square	Lack of dropped kerbs onto footway	Wheelchair and mobility uses would find it difficult to access the footway, there is only 1 dropped kerb at the sheltered housing entrance	Footway surfaces and obstructions

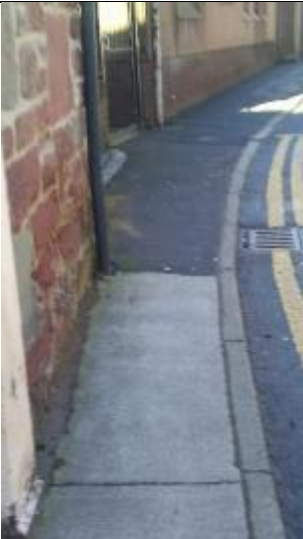
Footway from George Square to Causewayend	In poor state of repair and narrow width	Trip hazard for pedestrians, too narrow for wheelchair users	Footway surfaces and obstructions, road layout and space allocation

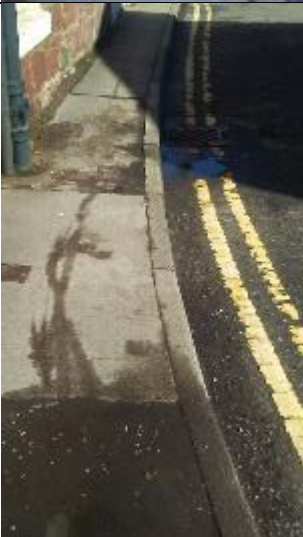
Footway from George Square to Causewayend	In poor state of repair	Trip hazard for pedestrians, too narrow for wheelchair users	Footway surfaces and obstructions

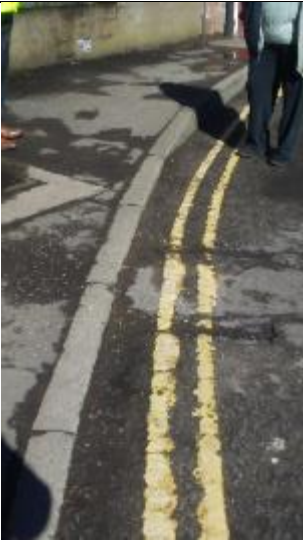
Footway from George Square to Causewayend	In poor state of repair	Trip hazard for pedestrians, too narrow for wheelchair users	Footway surfaces and obstructions

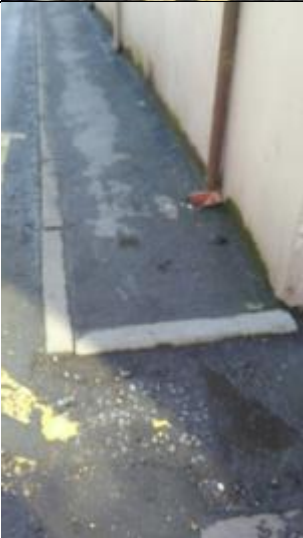
Narrow footway on Causewayend	Poorly maintained and too narrow for wheelchair, mobility aid or pushchair user to access	Pedestrians forced to walk along the road	Footway surfaces and obstructions and road layout and space allocation

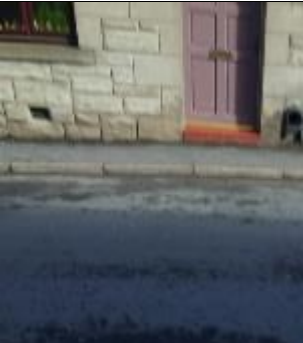
Narrow footway on Causewayend	Too narrow for wheelchair, mobility aid or pushchair user to access	Pedestrians forced to walk along the road	Footway surfaces and obstructions and road layout and space allocation

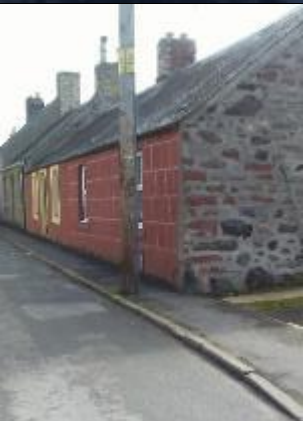
Narrow footway on Causewayend	Obstructed by large telegraph pole, poorly maintained and too narrow for wheelchair, mobility aid or pushchair user to access	Pedestrians forced to walk along the road	Footway surfaces and obstructions

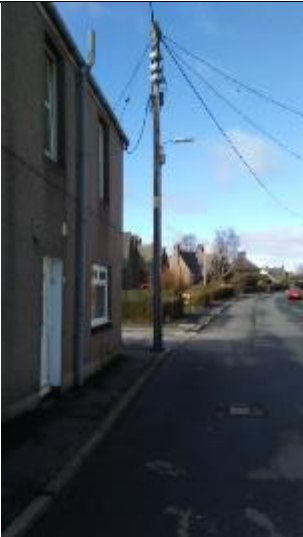
Narrow footway on Causewayend	Obstructed by large telegraph pole, poorly maintained and too narrow for wheelchair, mobility aid or pushchair user to access	Pedestrians forced to walk along the road	Footway surfaces and obstructions

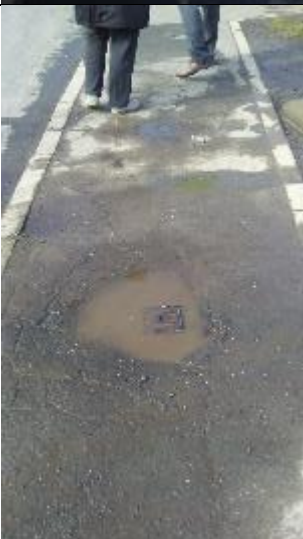
Footway on Causwayend beside Union Place	Poorly maintained footway surface around utility cover	Trip hazard for pedestrians	Footway surfaces and obstructions

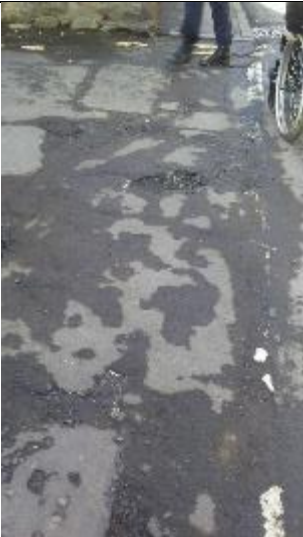
Footway on Causwayend	Poorly maintained footway surface	Trip hazard for pedestrians	Footway surfaces and obstructions

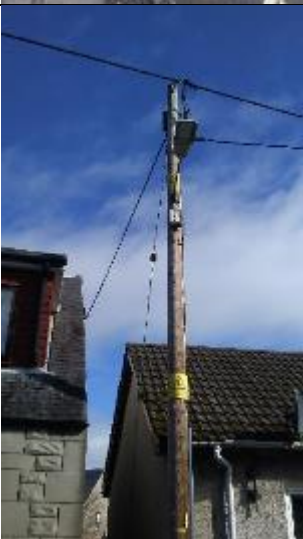
Narrow footway on Causewayend	Obstructed by large telegraph pole, poorly maintained and too narrow for wheelchair, mobility aid or pushchair user to access	Pedestrians forced to walk along the road	Footway surfaces and obstructions

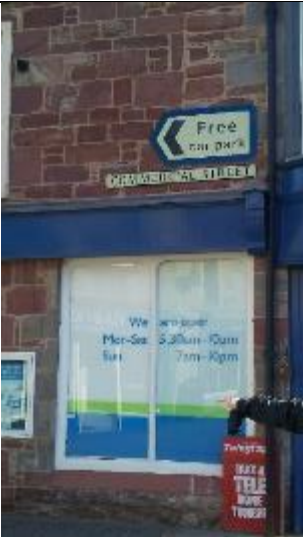
Entrance to Commercial St from Union Street	Raised road surface and advertising board	Advertising board obstructs footway, making it difficult for wheelchair and push chair to pass.	Footway surfaces and obstructions

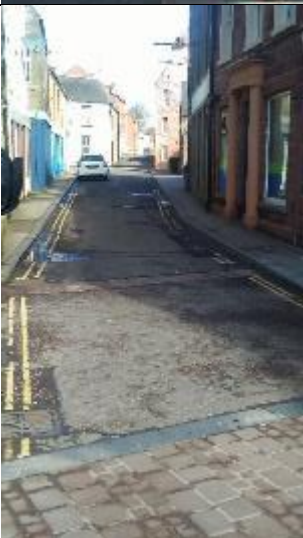
Commercial Street	Narrow street and narrow footways	Pedestrians using wheelchairs and pushchairs will need to walk on the carriageway	Footway surfaces and obstructions

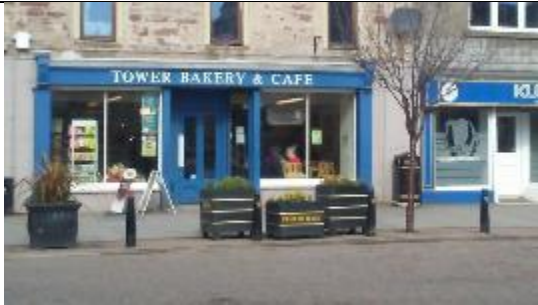
George Street	Planters, makes area look pleasant and inviting	Invites people to linger in the space	aesthetics

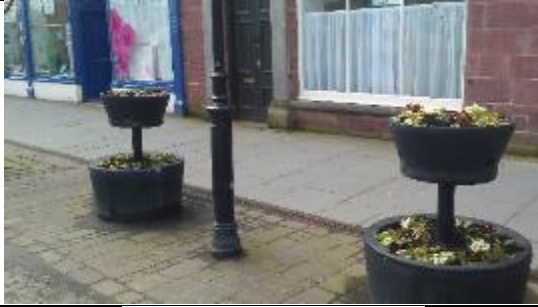
George Street	Planters, makes area look pleasant and inviting	Invites people to linger in the space	aesthetics

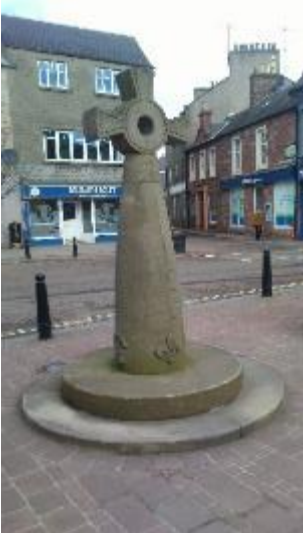
George Street, High Street in pedestrian space	Makes area look pleasant and inviting, Market cross There was a farmers market that used to meet in this area, there is scope for other civic events to be held here	Invites people to linger in the space	aesthetics

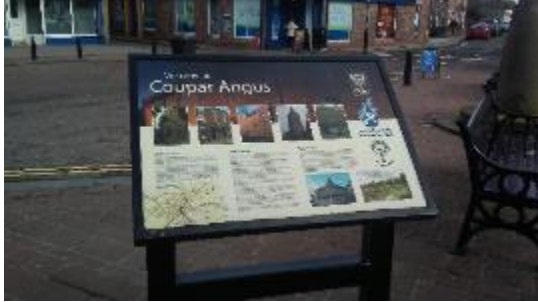
George Street, at entrance to pedestrian area	Information sign about Coupar Angus	Useful information for visitors to CA	Facilities and signage

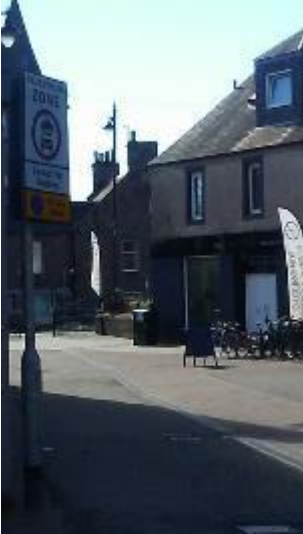
Pedestrian area, High Street	Well-kept flat space for pedestrians. There are often cars moving and parking in this space	Can be a pleasant space to walk, but dangerous at times with moving vehicles	Road layout and space allocation

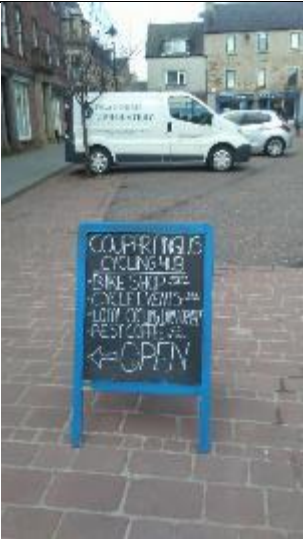
Pedestrian area, High Street	Advertising board	Could be a trip hazard for visually impaired	Footway surfaces and obstructions

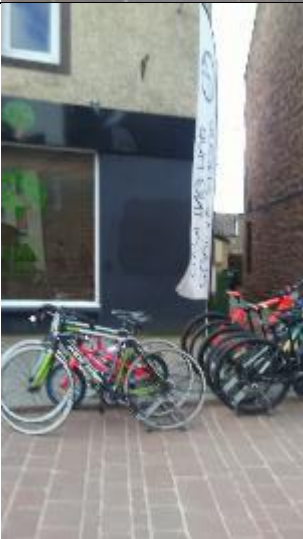
Pedestrian area, High Street	Bike stands with bikes	Could be a trip hazard for visually impaired	Footway surfaces and obstructions

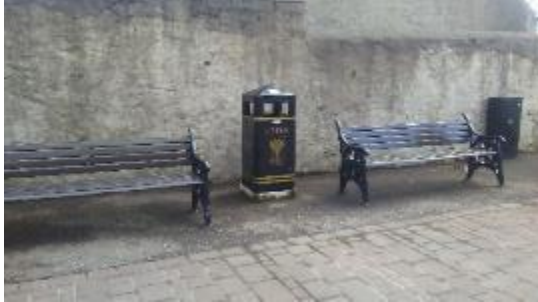
High Street pedestrian area	Seating with back and arm rest, litterbins	Opportunity for pedestrians to stop and rest	Facilities and signage

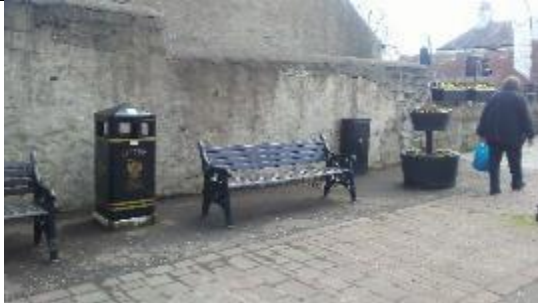
High Street pedestrian area	Seating with back and arm rest, litterbins	Opportunity for pedestrians to stop and rest	Facilities and signage

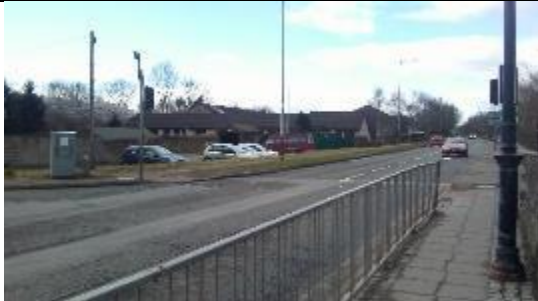
Exit from High Street to Burnside Road, opposite Queen Street junction	Barrier along footway opposite	Barrier marks end of pedestrian space and offers some safety from traffic moving through Queen Street junction	Footway surfaces and obstructions

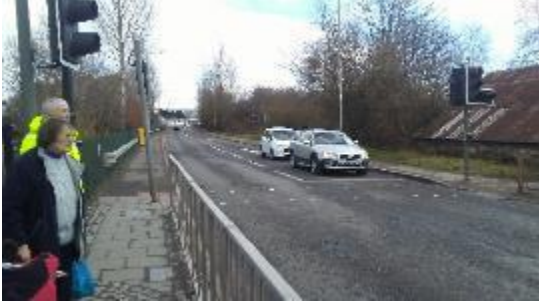
Exit from High Street to Burnside Road, opposite Queen Street junction	Barrier along footway	Barrier marks end of pedestrian space and offers some safety from traffic moving through Queen Street junction	Footway surfaces and obstructions

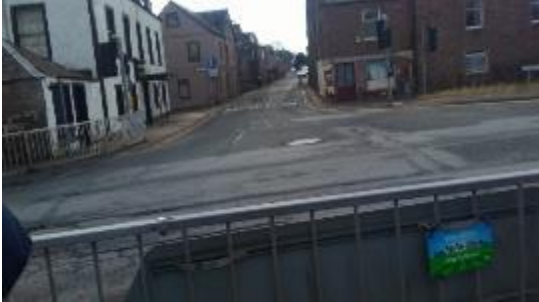
Exit from High Street to Burnside Road, opposite Queen Street junction	Barrier along footway	Barrier marks end of pedestrian space and offers some safety from traffic moving through Queen Street junction	Footway surfaces and obstructions

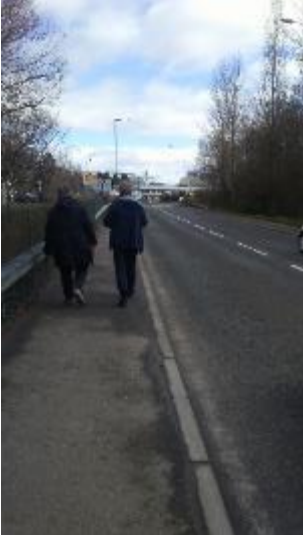
Burnside Road walking towards Station Road	Poor footway surface, beside busy main road. Pedestrians feel quite vulnerable due to volume, speed and proximity of traffic	Not a pleasant place to walk, especially if you were with children or less mobile	traffic

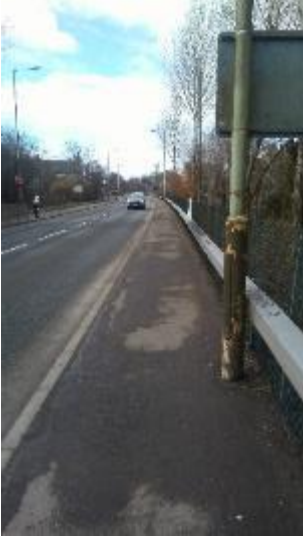
Burnside Road walking from Station Road	Poor footway surface, beside busy main road. Pedestrians feel quite vulnerable due to volume, speed and proximity of traffic	Not a pleasant place to walk, especially if you were with children or less mobile	traffic

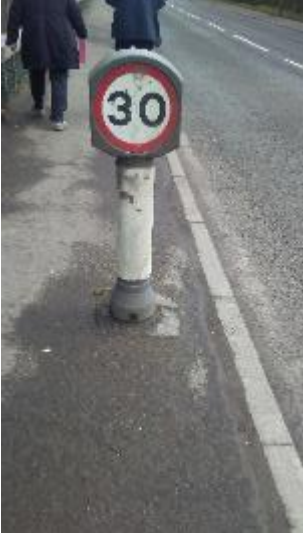
Burnside Road walking towards Station Road	Bollard with speed limit sign	This obstructs the footway and as it is low down drivers may not notice the sign	Footway surfaces and obstructions

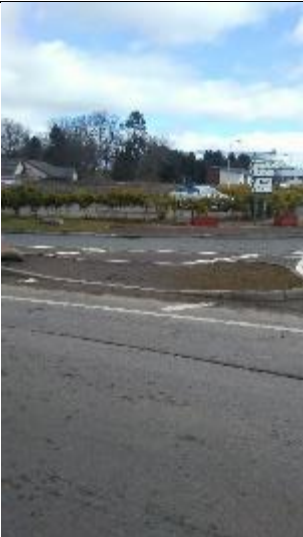
<p>Junction where Burnside Road meets Station Road, Island to cross towards care home</p>	<p>There is an island with dropped kerbs to aid crossing, but the island is narrow and is very close to a busy roundabout</p>	<p>This is quite an intimidating place to cross due to volume of traffic</p>	<p>Crossing points and desire lines</p>

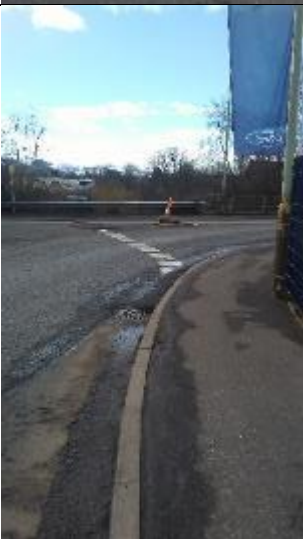
<p>Path at roundabout near Burnside and Station Roads junction</p>	<p>Footway quite wide and surface ok, but close proximity to busy road</p>	<p>Walking here is intimidating due to volume and proximity to traffic</p>	<p>traffic</p>

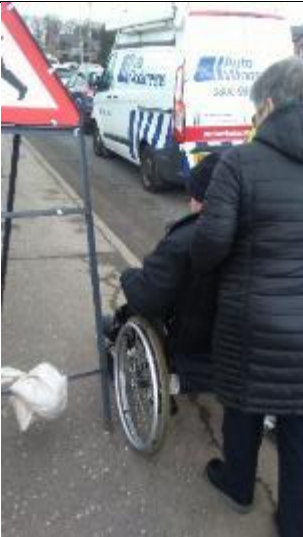
Station Road	Road traffic maintenance signs obstructing footway.	Difficult to traverse the footway, especially with a wheelchair.	Footway surfaces and obstructions

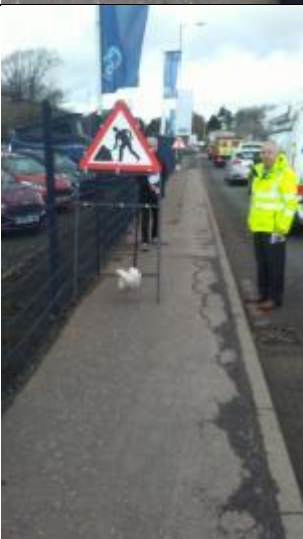
Station Road	Road traffic maintenance signs obstructing footway.	Difficult to traverse the footway, especially with a wheelchair.	Footway surfaces and obstructions

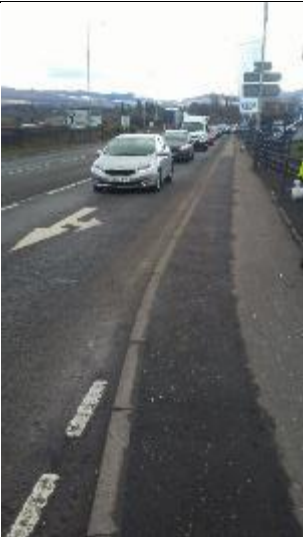
Station Road	Wide footway with ok surface.	Footway ok but dominated by traffic	traffic

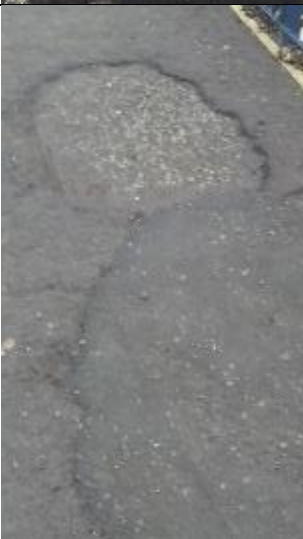
Station Road near Union Street corner	Poor footway maintenance, several holes	Trip hazard for walkers	Footway surfaces and obstructions

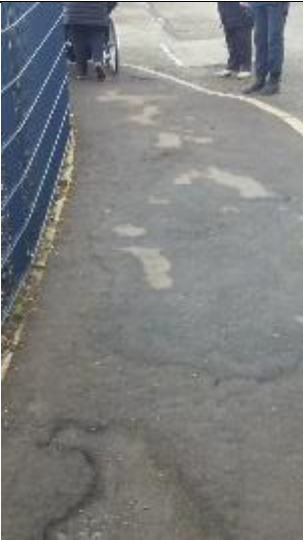
Station Road	Wide footway with ok surface.	Footway ok but dominated by traffic	Footway surfaces and obstructions

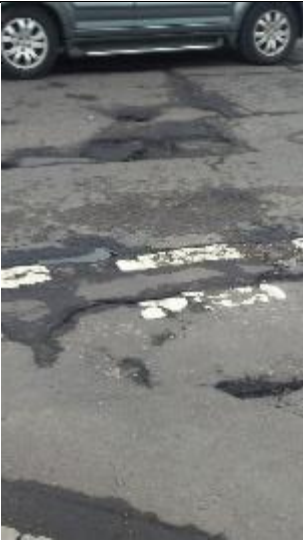
Victoria Street junction with Union Street	Poorly maintained carriageway	Difficult to cross for less mobile pedestrians	Footway surfaces and obstructions Crossing point

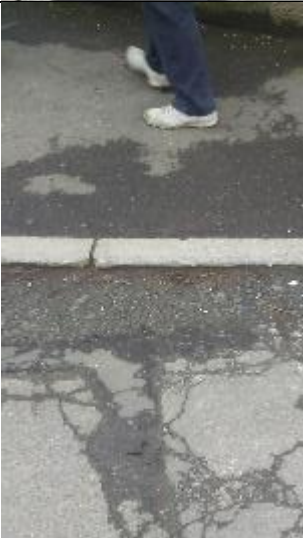
Victoria Street junction with Union Street	Poorly maintained footway with lack of dropped kerb	Difficult to cross for less mobile pedestrians, wheelchair or pushchair users.	Footway surfaces and obstructions Crossing point

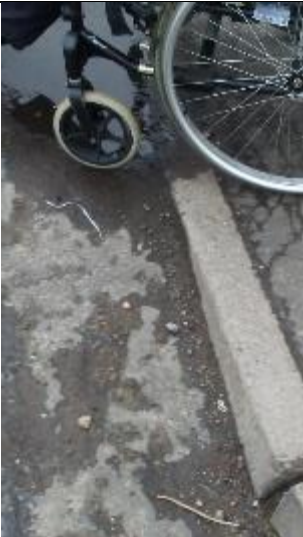
Victoria Street junction with Union Street	Poorly maintained footway with lack of dropped kerb	Difficult to cross for less mobile pedestrians, wheelchair or pushchair users.	Crossing point

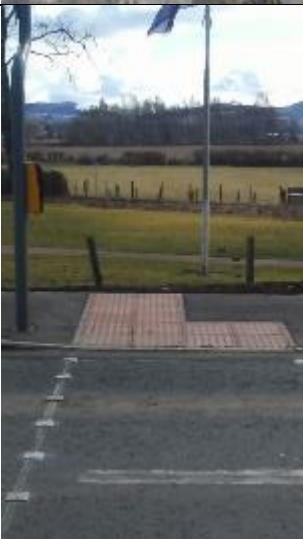
Forfar Road	New pedestrian crossing point installed	Crossing makes it easier for pedestrians and school children to cross road	Crossing point

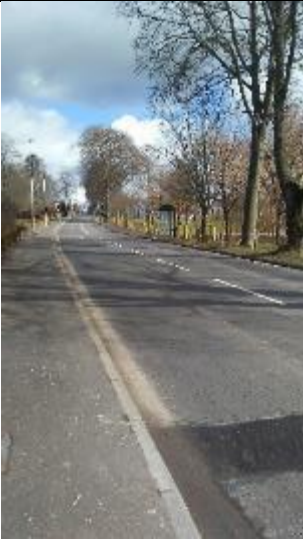
Forfar Road	Footway has been widened	Makes the route safer for pedestrians walking from housing estate to the school	Footway surfaces and obstructions

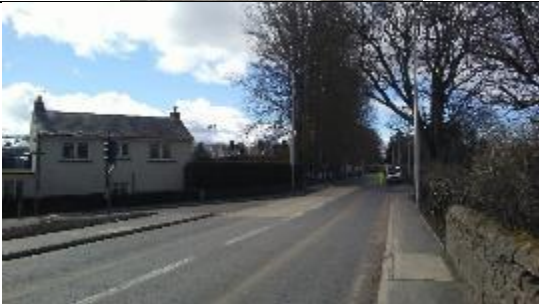
Forfar Road junction with Coupar Angus Road	Newly installed pedestrian crossing and pavements at the junction.	Safer crossing to the park.	Crossing point

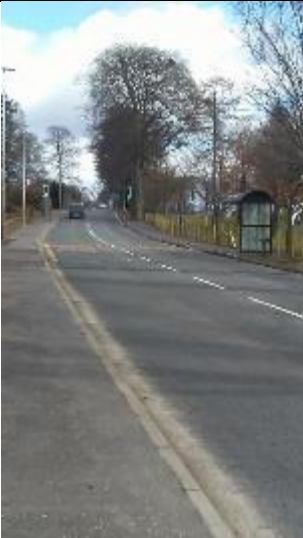
Forfar Road	Footway has been widened	Makes the route safer for pedestrians walking from housing estate to the school	Footway surfaces and obstructions
