# **Social Housing Partnership Fund for Improved Cycling & Walking Facilities 2019-20**

## **Assessment of Walking and Cycling Conditions, Fruin St/Sloy St, Glasgow (Hawthorne Housing Association)**

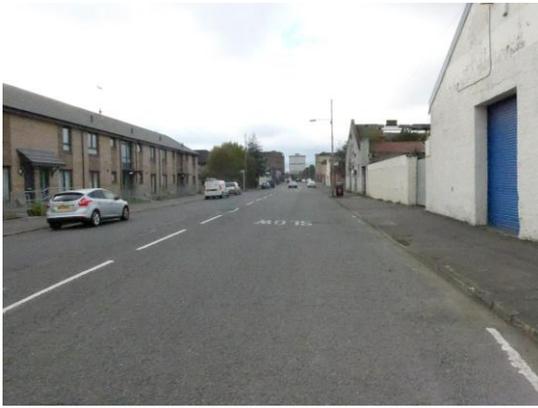
Project	Photos	Recommendations
[Some minor details have been deleted from this version of the report to safeguard the privacy of residents]	1	
<b>Immediate area</b>		
There are isolated issues but in broad terms footways in the area are relatively wide and in relatively good repair. However many junctions lack dropped kerbs or an equivalent. There appears to be a relatively large amount of space available for parking vehicles, so we observed little parking on the footway. This may change if new properties are built in the area, or if the area becomes more prosperous with a higher car-ownership.		a
It appears that there is comparatively little temporary clutter on the footways in the area, with space for bin storage generally appearing to be off the street.		
The streets in this local area tend to be very wide – some carriageway space is around 12 metres wide. Many other fully-residential streets in the wider area might more typically have a carriageway 7-9 metres wide. These wide streets appear to carry comparatively little traffic, with some streets blocked off at strategic locations, some with temporary infrastructure.	2

<p><b>1: Back garden area (site of project)</b></p>	<p><b>2: Streets in the local area are very wide</b></p>

<b>Immediate/wider area</b>
a	The association should make itself aware of the general barriers to walking and cycling that residents face, on the basis that the association can add weight to their wishes or could choose to speak on their behalf in pursuing improved conditions.
b	The association should recognise that barriers to wider walking and cycling more widely, including on routes to the city centre, may be significant in defining elements of daily life for its residents – limiting their options for access to the city’s resources to those in the immediate vicinity, or to those which it makes sense to access by bus, car or taxi.

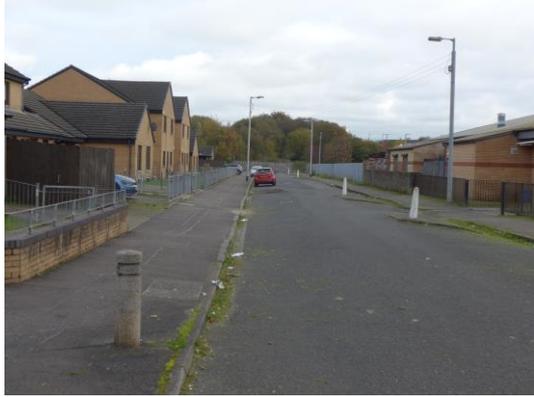
Streets which are both very quiet and very wide, as above, may already be providing an environment that a high proportion of people would find acceptable for cycling.

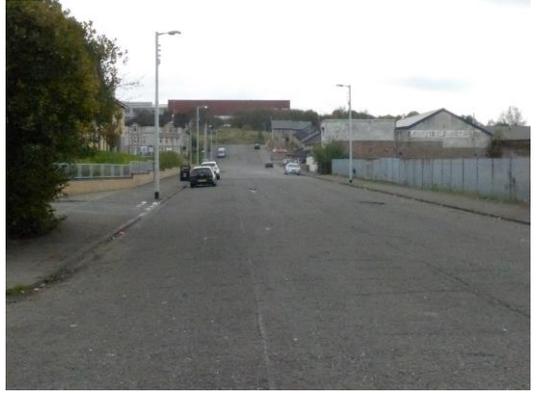
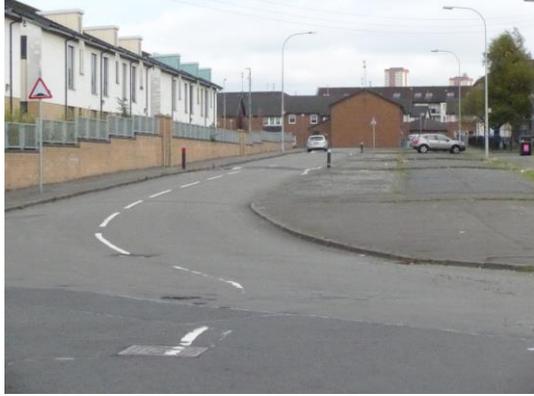
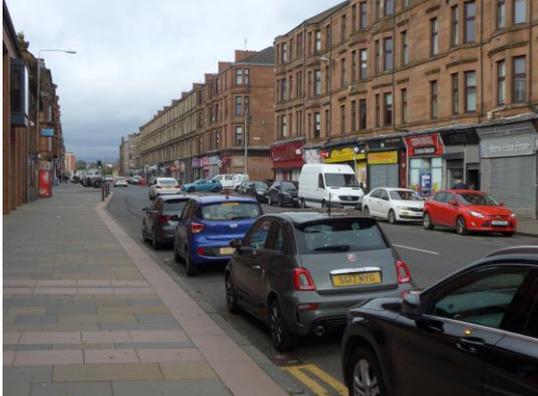
There are a high number of locations and streets in this area which lack 'active frontage' – in other words it might be assumed that activity on the street is relatively unlikely be observed from (or heard within) within nearby buildings. Such streets can be considered to be unwelcoming for pedestrians after dark, and at quiet periods.	2,3 4,5	a
Many of the streets which (as above) might be less welcoming to pedestrians at quiet times or after dark, and which (as above) have low levels of traffic on wide carriageways, may remain more welcoming for people cycling. On this basis there is potential for bicycle use to be more attractive to local residents than walking, even for shorter journeys.		
<b>Wider area</b>		
The most obvious local community facilities, including shops, bus routes, and similar, are on Saracen Street [SS] south of Saracen Cross [SC] around 500 metres away. There are few other obvious locations of a similar nature in the vicinity.	6	a,b

<p><b>3: Lack of active frontage</b></p>	<p><b>4: Lack of active frontage</b></p>

<p><b>5: Lack of active frontage</b></p>	<p><b>6: Shops at Saracen Street</b></p>

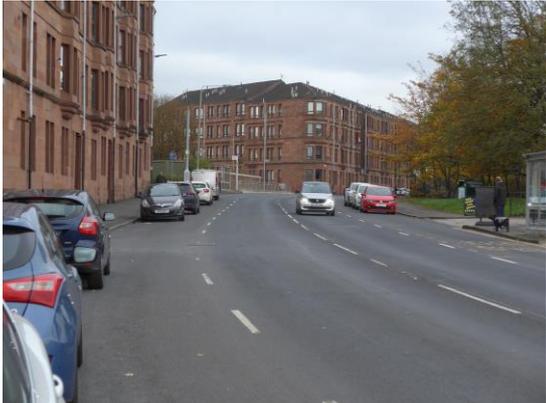
There is a Lidl supermarket [SM] around 700 metres from the properties (perhaps 900m on foot).  There did not appear to be any official location for customers to park bicycles nearby (nor was any good alternative immediately obvious). There is a pedestrian access through surrounding wooden fencing, with one route at the edge of the car park supported by 'zebra' markings.		a,b
There seem to be no other obvious larger supermarket-style shops in the local area.		a,b
The railway to the east of this location, and areas near this which are of a more industrial nature, and the motorway to the south with its associated lack of residential areas, offer considerable barriers to walking and cycling in these directions. The city centre is only around 2 km to the south, which in theory could be a very easy distance for most people to cycle.		a,b
Cycling west on a route under the railway bridge [R1] at Hawthorn Street utilises a carriageway that few people will find welcoming.	7	a,b

<p><b>7: Route under railway, Hawthorn St [R1]</b></p>	<p><b>8: Route over railway, Keppochhill Rd [R2]</b></p>

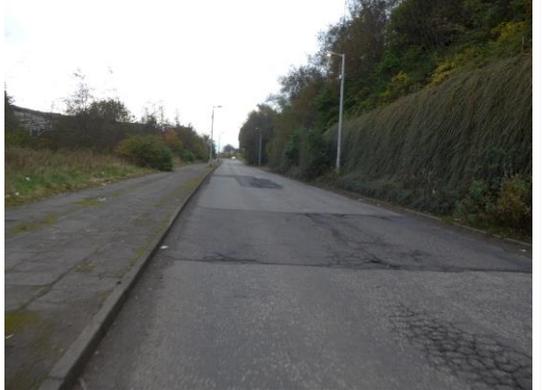
The only other available (westbound) crossing of the railway is at Keppochhill Road. This uses a bridge [R2] over the railway which might be more welcoming, but there are 4 carriageway lanes here. Access to this location involves the use of Carlisle	8,9	a,b

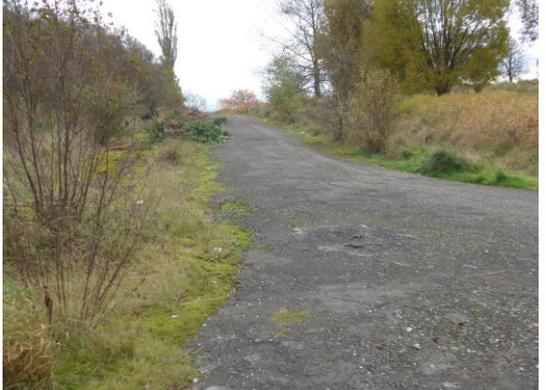
Street [CS]. This has little or no active frontage - is primarily industrial, with derelict land in places, and overgrown greenery – yet is narrow and seems typically to be driven at a higher speed.		
Southbound trips, either by bicycle or for pedestrians, through the brownfield land south of Fruin Street, and the local parkland further south [P] are unwelcoming. The parkland is generally rough grassland, with brownfield land [B] beside it (where housing existed previously).	10,11	a,b
The remaining main route south, either on a bicycle or for a pedestrian, would utilise Saracen Street – which becomes Craighall Road further south. For much of its length (to the south) this Saracen Street is marked with 4 carriageway lanes (and seems designed almost entirely around carrying vehicles at considerable speed) – making it very unwelcoming for cycling. Further south it becomes more industrial in nature, with no residential property overlooking it. At the point Craighall Road narrows as it approaches the M8 motorway it is also very separate from other signs of human activity – feeling more like a motorway slip road.	12,13, 14	a,b

<p><b>9: Carlisle Street [CS]</b></p>	<p><b>10: Brownfield land south of Fruin St [B]</b></p>

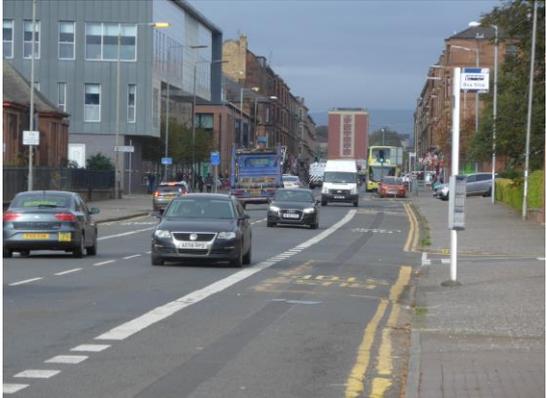
<p><b>11: Parkland south of Fruin St [P]</b></p>	<p><b>12: Saracen Street (4 carriageway lanes)</b></p>
